Firefighter Safety and Photovoltaic Installations Research Project

Issue Date: November 29, 2011

EXECUTIVE SUMMARY

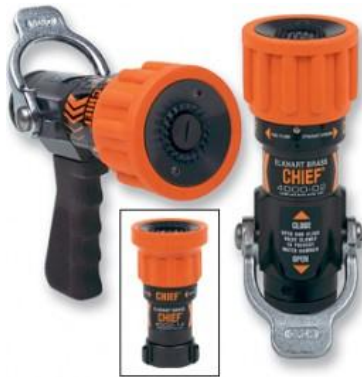
Figure 4 Smooth bore nozzle

Smooth Bore – The smooth bore nozzle was made of aluminum with three stacked tips, 1 inch, 1-1/8 inch, and 1-1/4 inch. The nozzle(s) connected to a saber-type shutoff valve for connection to a 1-1/2 inch hose - Figure 4.

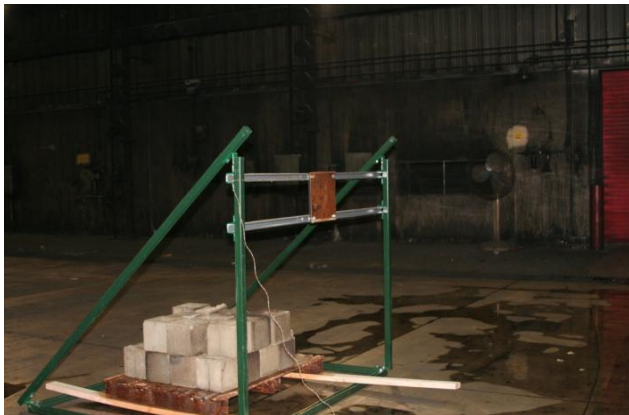
Figure 6 Target plate on skid

The voltage source for these tests was a DC power supply adjustable from 0 to 1000 Volts direct current (VDC). The positive (+) side of the supply was connected to a copper plate, 12 inches square, mounted in the vertical position five feet from ground on a movable skid. The negative (-) side of the supply was grounded and connected to the brass fitting connection on the hose (1-1/2 inch) at the nozzle. A 500 Ohm resistor was also included in the test circuit to represent the human body impedance¹⁷. The current produced in the circuit from the plate, through the hose stream, and back to the nozzle/hose fitting was then measured under various conditions of nozzle type, water pressure, and distance. Figure 6 and Figure 7 illustrate the test fixture.

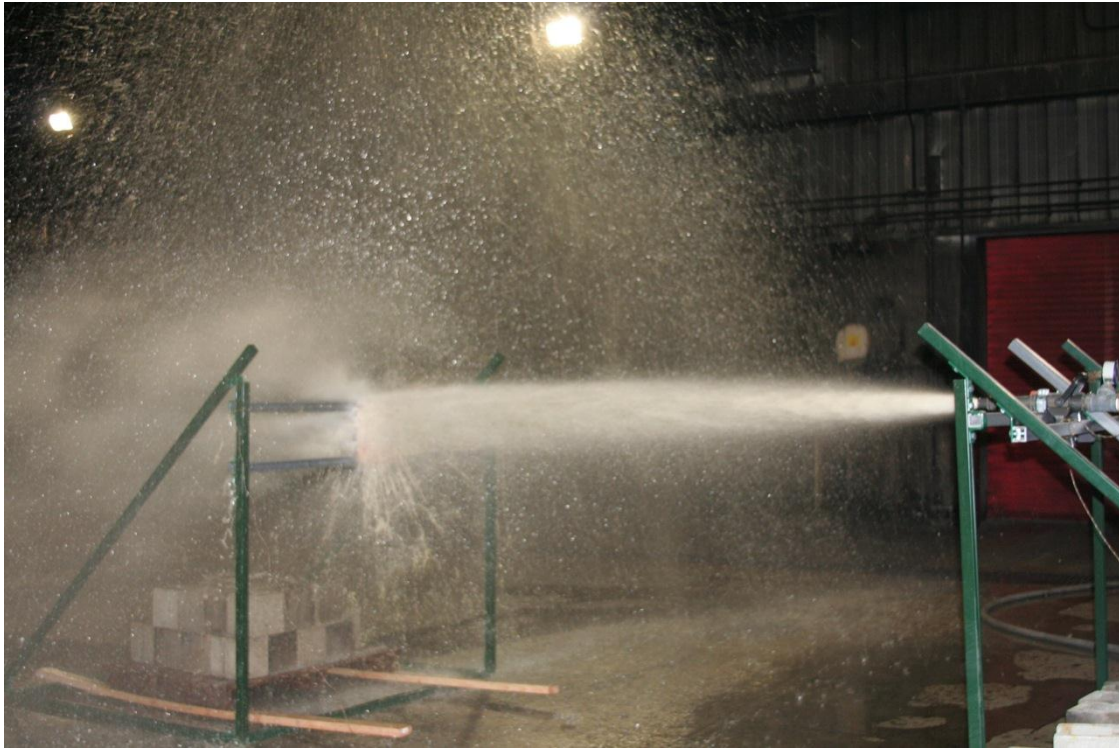
Figure 8 Water stream aimed at energized target plate

Each experiment consisted of placing the target copper plate a fixed distance from the nozzle. A particular nozzle type and water pressure was then chosen. With the nozzle spray aimed at the target, the power supply was turned on at 1000 VDC. Data acquisition of voltage and current then began, and the voltage was gradually lowered from 1000 VDC to 50 VDC, dwelling for several seconds at the fixed voltages of 1000, 600, 300 and 50. Figure 8 illustrates a steady water stream aimed at the energized target plate.

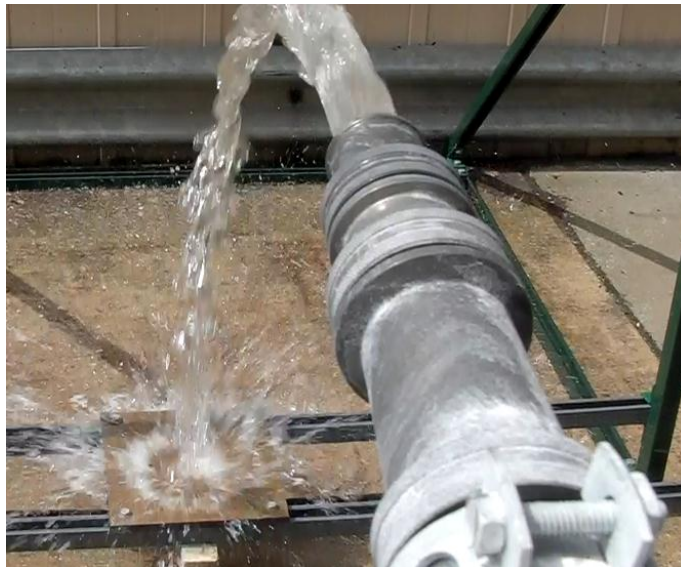
Figure 9 Water stream aimed at flat (horizontal) energized target plate

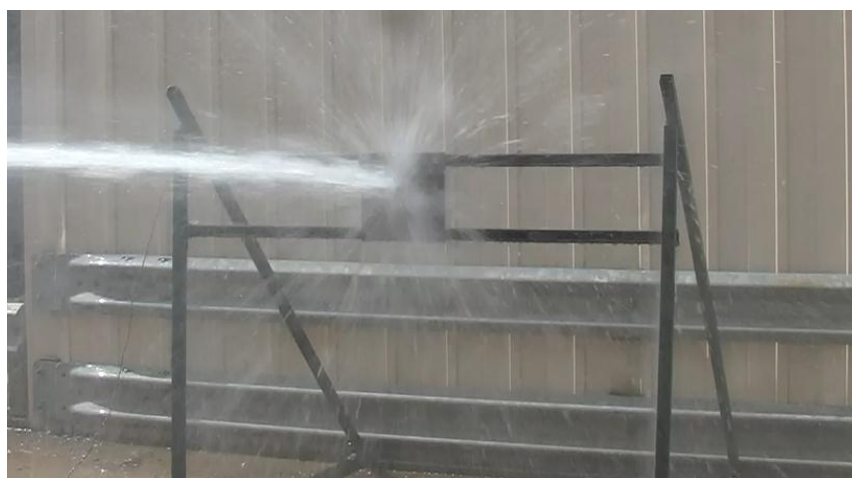
Figure 10 Water stream breaking up and dispersing near target plate

Initial experiments at 1000 VDC with pond water ($\approx 1100 \text{ uS/cm}$) and a 1-1/4 inch nozzle with a solid stream at 10 feet, produced less than 4 mA of leakage through the hose stream. The calculated maximum leakage current at these parameters is almost 30 mA^{18} . The reason for this reduction in current under actual test conditions is likely due to the breakup of the solid stream over this 10 foot distance, and the dispersion of the water as it hit the target plate. These factors all created additional resistance in the water circuit, and thus resulted in less current through the water stream than expected. Figure 10 Water stream breaking up and dispersing near target plate illustrates stream pattern impacting vertical target.

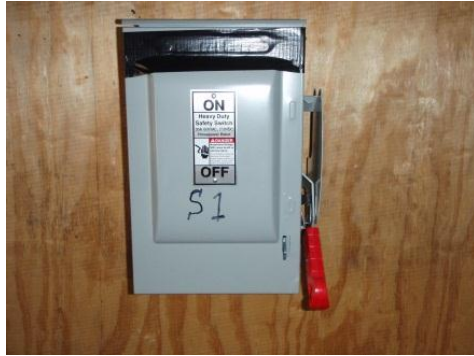
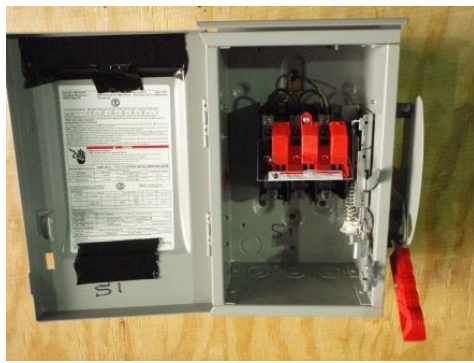
Figure 11 Switch S1

Figure 12 Switch S1 Open

Switch S1 – Disconnect switch rated 30 A, 250 VDC, Type 3R. Enclosure size 11 x 6-1/2 x 5-1/2 inches deep. Provided with a hinged door with no gasket. Figure 11 and Figure 12

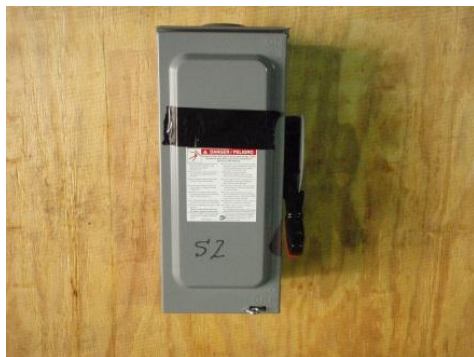
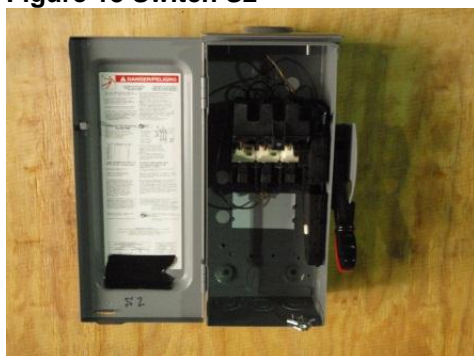
Figure 13 Switch S2

Figure 14 Switch S2 Open

Switch S2 – Disconnect switch rated 30 A, 600 VDC, Type 3R. Enclosure size 14 x 6 x 4 inches deep. Provided with a hinged door with no gasket. Figure 13 and Figure 14

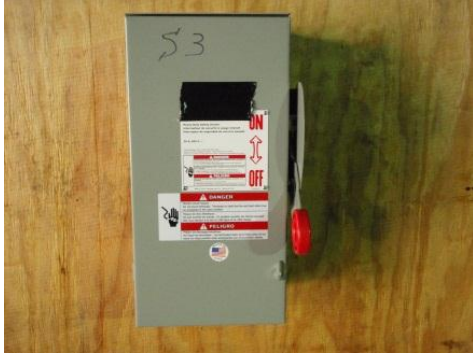
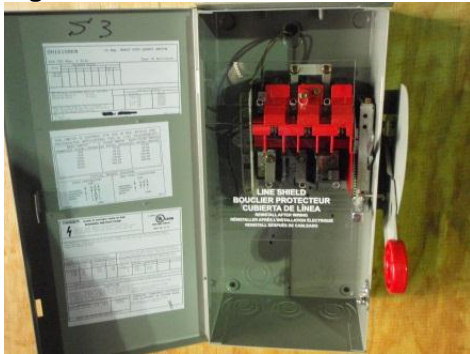
Switch S3 – Disconnect switch rated 30 A, 600 VDC, Type 3R. Enclosure size 16 x 8 x 5 1/2 inches deep. Provided with a hinged door with no gasket.

Figure 15 Switch S3

Figure 16 Switch S3 Open

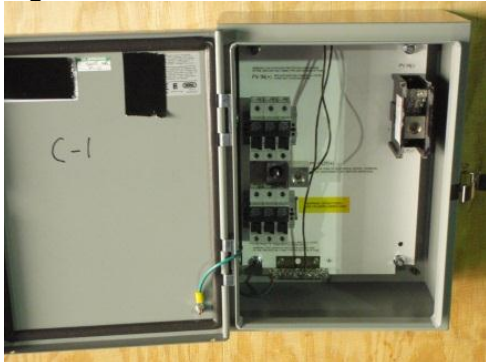
Figure 18 Combiner Box C1 Open

Combiner Box C1 – Combiner Box rated 30 A, 600 VDC, Type 3R. Enclosure size 16 x 12 x 7-1/2 inches deep. Provided with hinged door and gasket. Figure 17 and Figure 18

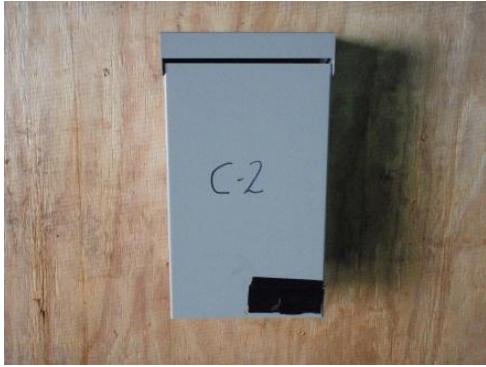
Figure 19 Combiner Box C2

Combiner Box C2 – Combiner Box rated 120 A, 600 VDC, Type 3R. Enclosure size 13 x 8 x 3-1/2 inches deep. Provided with telescoping door with no gasket. Figure 19 and Figure 20

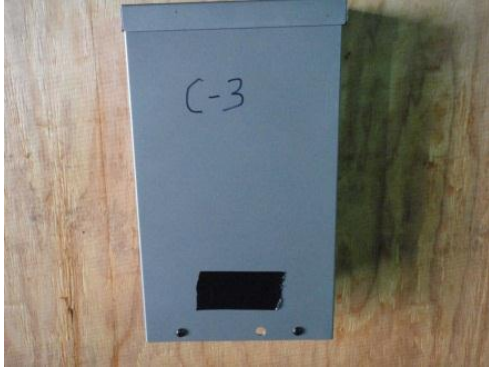
Figure 21 Combiner Box C3

Combiner Box C3 – Combiner Box rated 120 A, 600 VDC, Type 3R. Enclosure size 14 x 9 x 4 inches deep. Provided with telescoping door with no gasket. Figure 21 and Figure 22

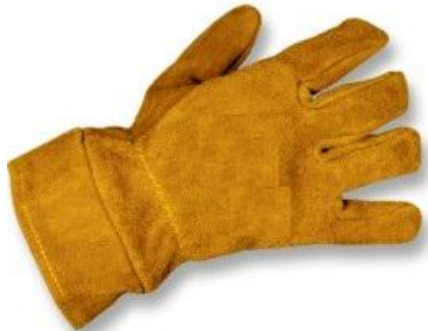
Figure 23 Glove 1

Glove #1 – Described in a supplier’s catalog as a supple all-leather, lightweight construction leather glove to provide basic fire protection. Offers a roomy Gunn cut design with wing thumb, seamless index finger for extra durability, full sock-type liner of comfortable flame resistant SEF material, and a 2" leather cuff. These gloves are claimed to meet FED, CAL-OSHA specifications, but do not meet NFPA standards. Cost \$33.95. Figure 23

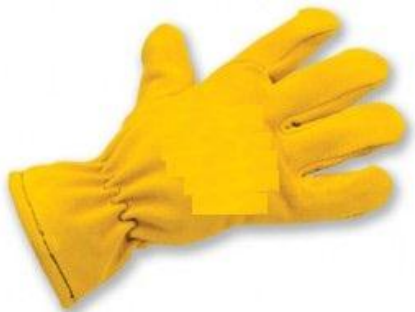
Figure 24 Glove 2

Glove #2 - Described in a supplier’s catalog as offering unmatched comfort, protection and performance in an NFPA fire glove. Waterproof, breathable barrier system that is the same proven technology used by many of the leading turnout gear manufacturers. Every liner is sewn, seam sealed and 100% dunk tested. Technology designed for better dexterity, no liner pull-outs and performance even after exposures in hot structural environments. Heavy weight tanned outer shell claimed to remain soft after repeated soakings. Cost \$47.95. Figure 24

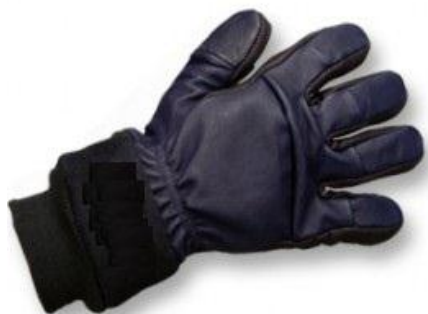
Figure 25 Glove 3

Glove #3 - Described in a supplier’s catalog as true 3-D hand-shaped styling with staggered layer seaming, and construction with dead air spacer ridges to allow natural hand flexing. Black cowhide cuffs with top grain kangaroo leather on back for easy flex and durability. High temperature stable and durable moisture barrier and wool 3-D heat guard on the back of hand to deliver extra insulation and thermal lining architecture that preserves microcapsules of air for thermal protection without traditional bulk. UL Classified to NFPA 1971, 2007 edition. Cost \$133.95. Figure 25

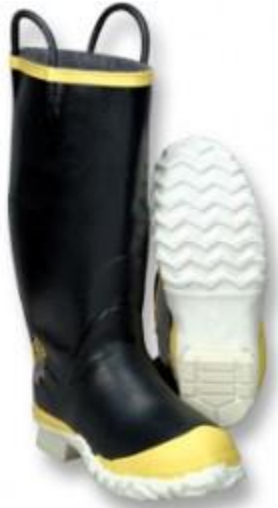
Figure 26 Boot 1

Boot #1 - Described as a fire-grade rubber boot formulated for high-heat stability, watertightness and resistance to contaminant deterioration. Provided with an extra-dense lining of heavy duty wool felt plus a polyfoam insulation covering the entire foot and shaft. Offers protection with built-in steel toe cap, bumper guards, tempered steel shanks and stainless steel midsoles. Boots have a durable outsole that provides protection and stability. Claimed to exceed NFPA standards, and meets all ANSI, OSHA & CAL-OSHA standards. UL Classified to NFPA 1971, 2007 edition. Cost \$143.95. Figure 26

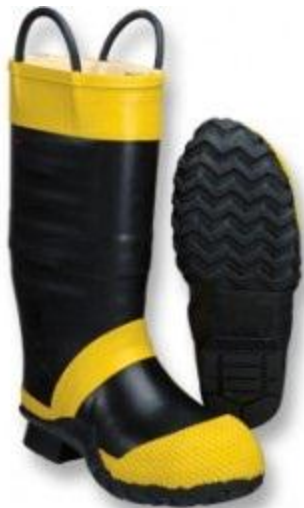
Figure 27 Boot 2

Boot #2 - Described as designed to be up to 25% lighter than heavier conventional fireboots. Incorporates innovative latex rubber dipping process that eliminates seams and produces lighter weight boots. High abrasion resistant outsole and heel with built-in shin guard and foot-guard protection system. UL Classified to NFPA 1971, 2007 edition. Cost \$153.95. Figure 27

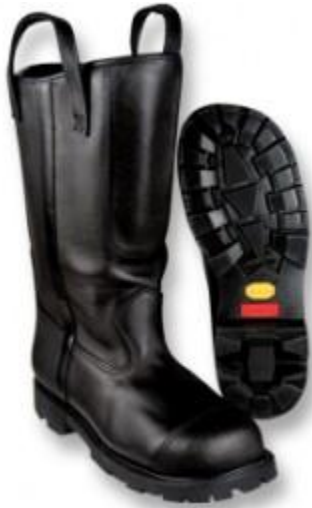
Figure 28 Boot 3

Boot #3 - Described as waterproof, flame and cut-resistant leather upper. Polyurethane insole with removable insert, plus rubber midsole and steel shank with built-in shin guard and steel toe. Waterproof and blood borne pathogen resisting lining. Claimed to meet ASTM F2413-05. UL Classified to NFPA 1971, 2007 edition. Cost \$239.95. Figure 28

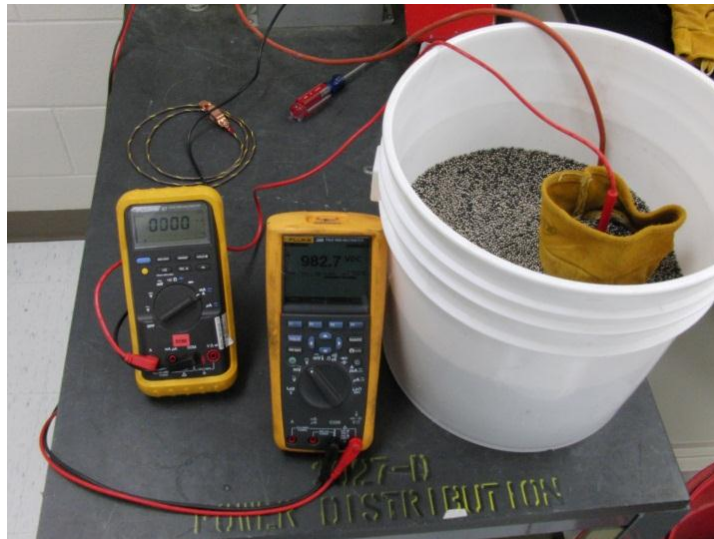
Figure 29 Testing a glove in metal shot

Figure 29 illustrates the dry glove test configuration.

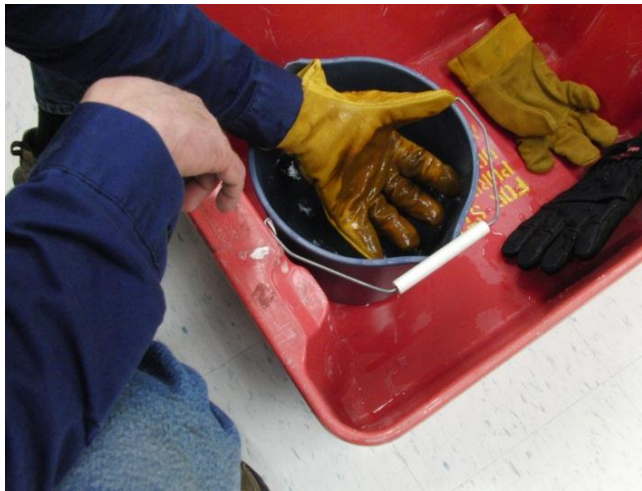
Figure 30 Wetting a glove before test

Figure 30 illustrates the wet glove test configuration.

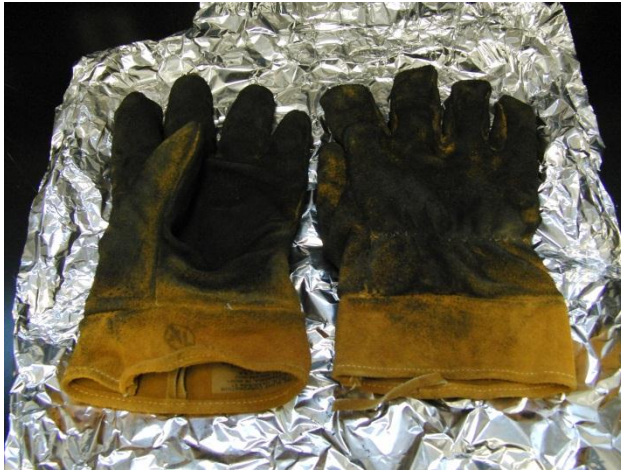
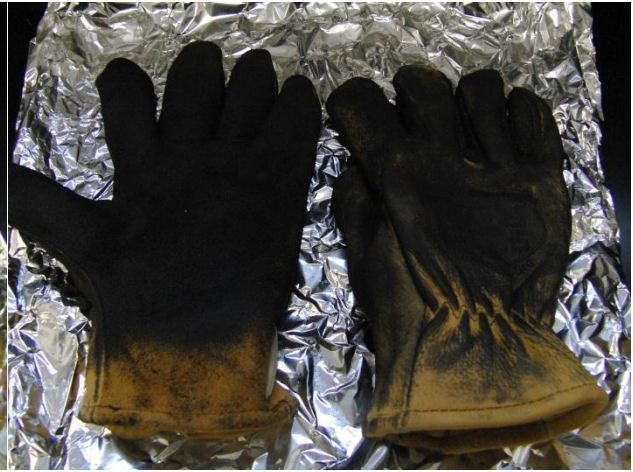
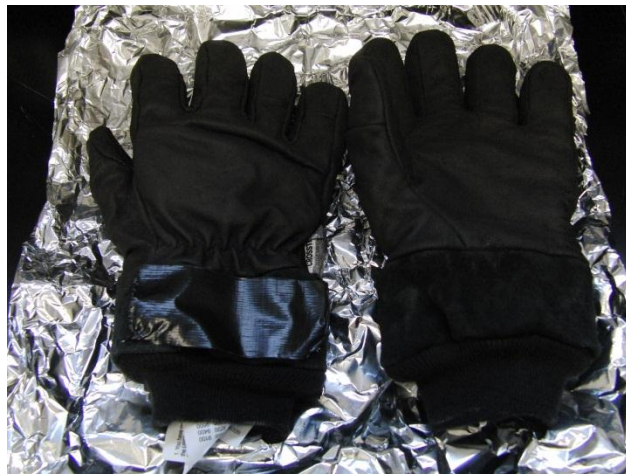
Figure 31, Figure 32 and Figure 33 illustrate gloves 1, 2 and 3 as soiled specimens.

Figure 31 Glove #1 soiled

Figure 32 Glove #2 soiled

Figure 33 Glove #3 soiled

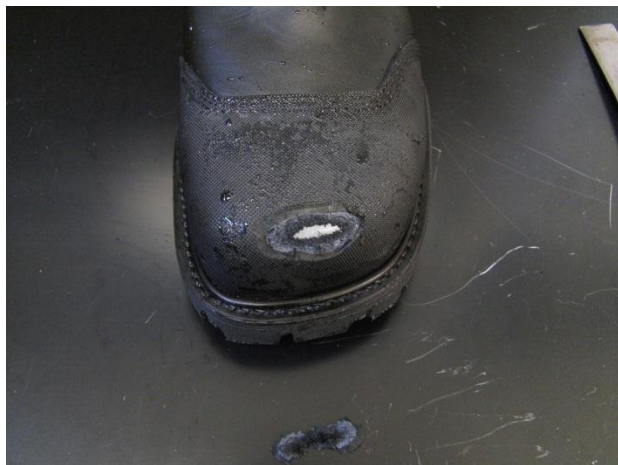
Figure 37 Boot #3 with material removed

Figure 37 illustrates material removed from boot #2 exposing the steel toe plate. Figure 38 illustrates material removed exposing the steel shank of boot 2.

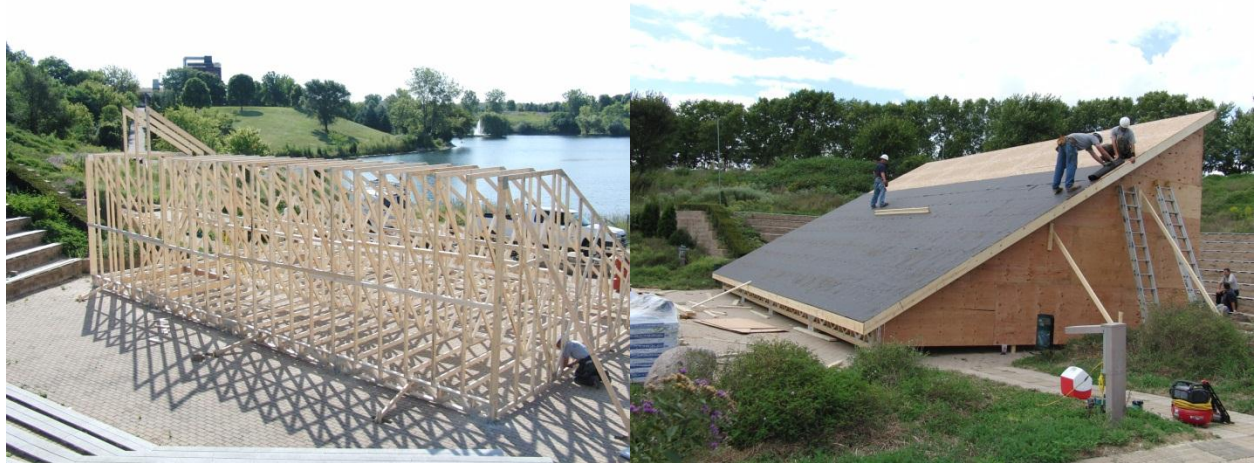
Figure 39 Construction of temporary PV test structure

For testing purposes, a temporary structure and PV test array was built at the UL facility property located in Northbrook, Illinois. The structure upon which the array was mounted consisted of an approximate [28 x 48 ft] wood building (wooden truss design) with a single-sided roof surface 48 ft long and 32 ft wide at a 7:12 slope. The roof was sheathed with 5/8 in O.S.B. and covered with 15 lb felt paper and Class A gray asphalt shingles. The roof surface was faced in a south direction. Figure 39 illustrates the roof for the PV array under construction.

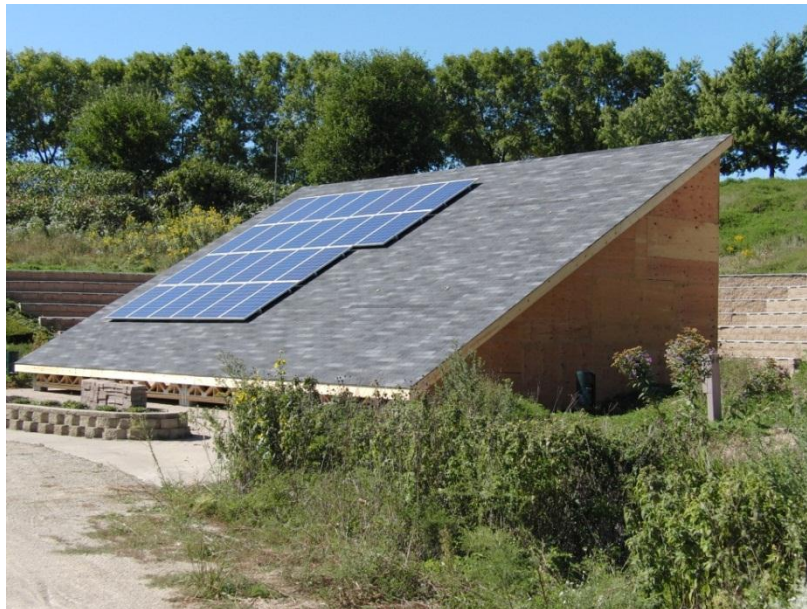
Figure 40 Main test array with 26 PV modules

The main test array consisted of 26 PV framed modules rated 230 W each (5980 W total rated power). Each module was rated 37.08 V open circuit (Voc), 8.11 A short-circuit current (Isc). At maximum power, the rated voltage is 20.45 V (Vmp), and rated current is 7.55 A (Imp). Each module measured 1652 mm by 992 mm, with a depth of 50 mm and weight of 23.5 kg. Each module contained 60 multicrystalline silicon cells in a 10 x 6 matrix series connected. The construction included three by-pass diodes, and a front tempered glass 3.2 mm thick.

With all 26 framed modules wired in series, the maximum open-circuit voltage was 964 V, and at maximum power the voltage would be 792 V. The roof structure also included an open test bed area, approximately 19 ft wide adjacent to the main array, where additional modules and/or different PV technology devices could be mounted and wired to the main array for test purposes.

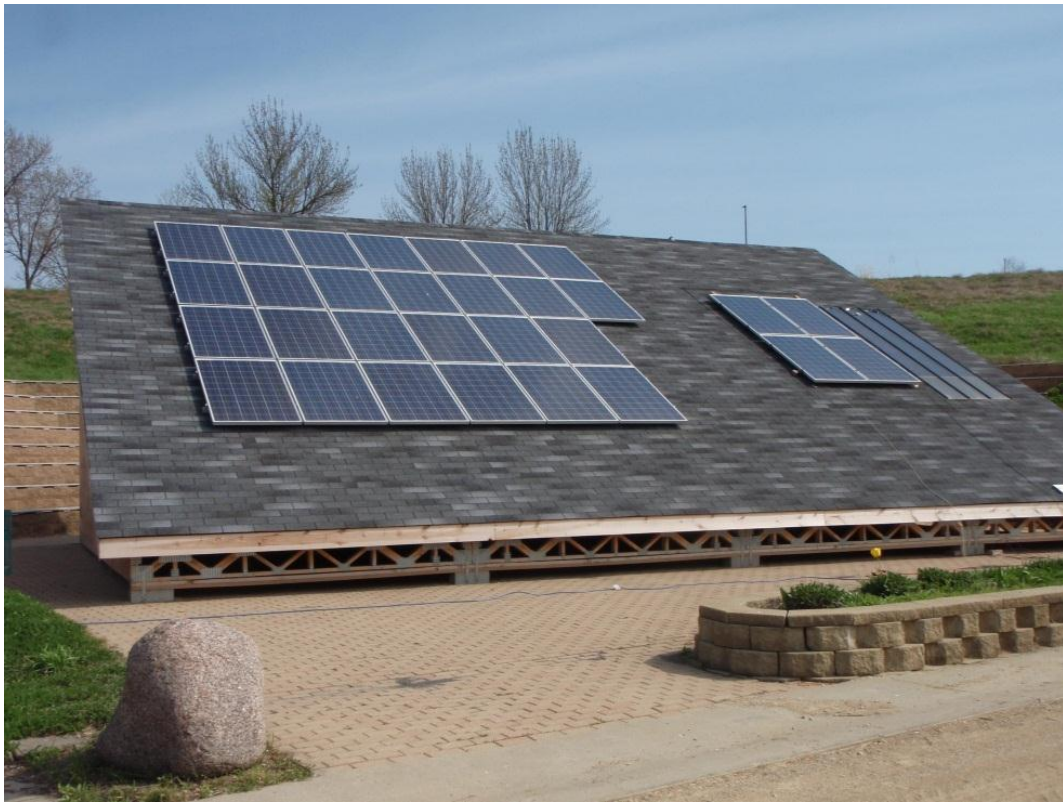
Figure 41 Complete structure with PV framed modules and laminates

A second PV technology consisted of PV laminate modules mounted to metal pans (18 inches on center) typical of a standing seam metal roof construction. Each laminate was rated 68 W (P_{max}), 23.1 V open circuit (V_{oc}), 5.1 A short-circuit current (I_{sc}). At maximum power, the rated voltage is 16.5 V (V_{mp}), and rated current is 4.13 A (I_{mp}). Each laminate measured 2849 mm by 394 mm, with a depth of 4 mm and weight of 3.9 kg. Each laminate contained 11 amorphous silicon cells connected in series, with a by-pass diode connected across each cell.

Figure 41 illustrates the PV array with test specimens installed on the right.

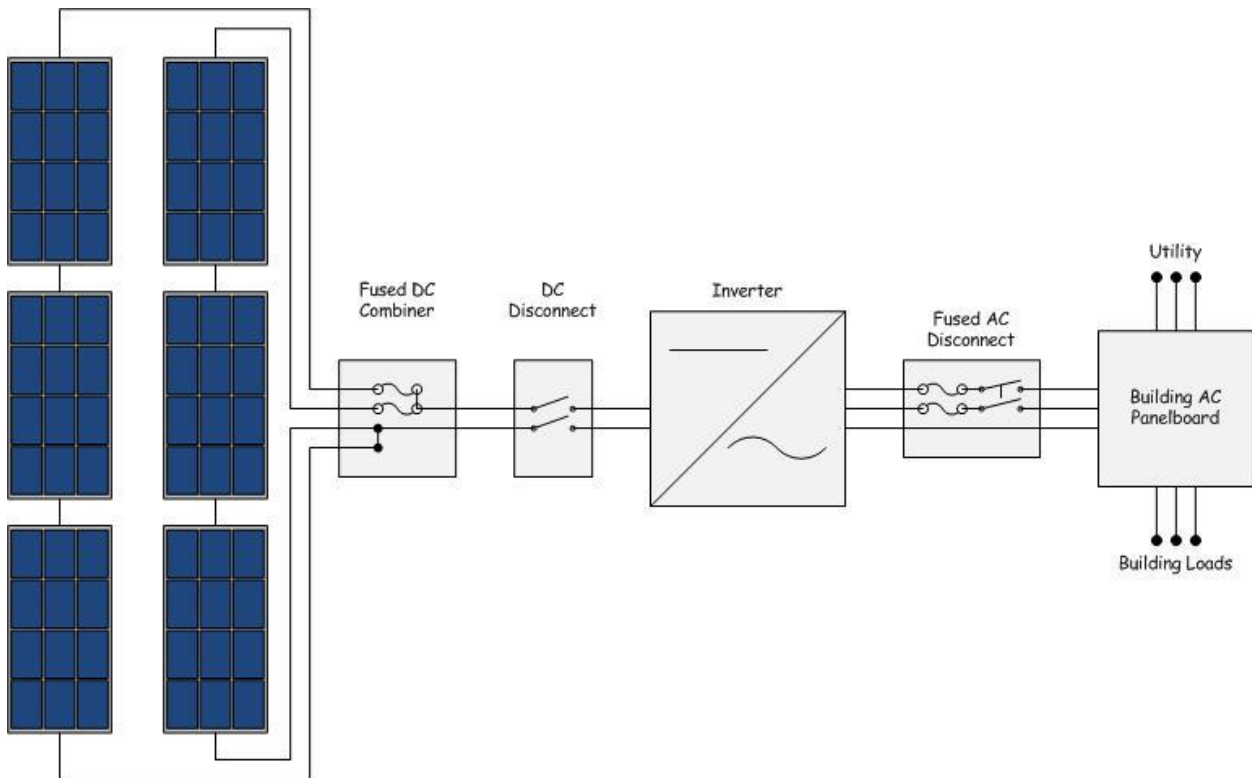
Figure 42 Diagram of typical PV system with required disconnects

Article 690 of the National Electrical Code® (NEC®) requires PV systems to be provided with a means to disconnect all current-carrying DC conductors of a PV system from all other conductors in the building or structure. This disconnecting means must be located at a readily accessible location on the outside of the building, or inside nearest the point of entrance of the system conductors. The disconnecting means must also be marked to identify it as a PV system disconnect. In addition to disconnecting the PV DC conductors, a means must also be provided to disconnect equipment, such as inverters and charge controllers from all ungrounded conductors. Figure 42 illustrates a typical PV component configuration.

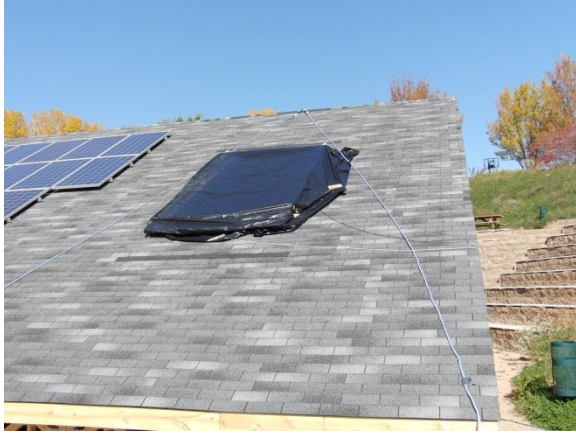
Tarp #1 –10 x 25 foot black plastic film sheet, 4 mils thick. Cost \$15.

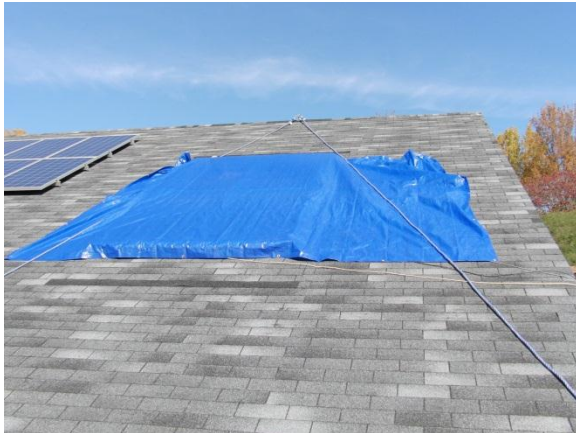
Tarp #2– 12 x 16 foot all-purpose tarp, 5.1 mil thick, blue in color. Cost \$16.

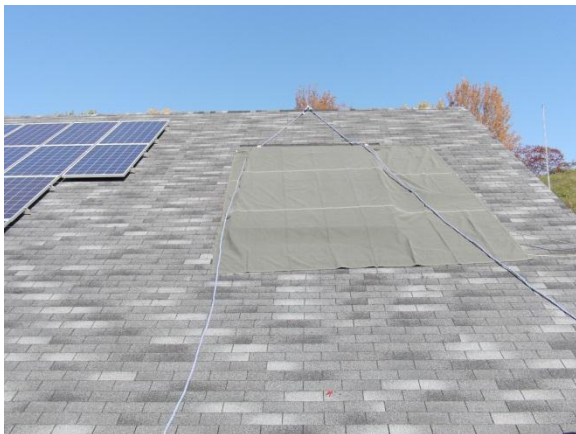
Tarp #3 – Canvas fire salvage tarp, green in color. Claimed to meet NFPA 701²⁴. Cost \$78.

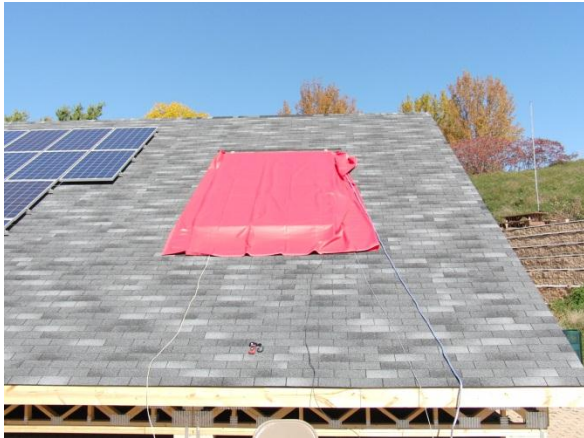
Tarp #4 – 12 x 14 foot heavy vinyl fire salvage tarp, red in color. Claimed to meet ASTM E-84²⁵ and UL 214²⁶. Cost \$94.

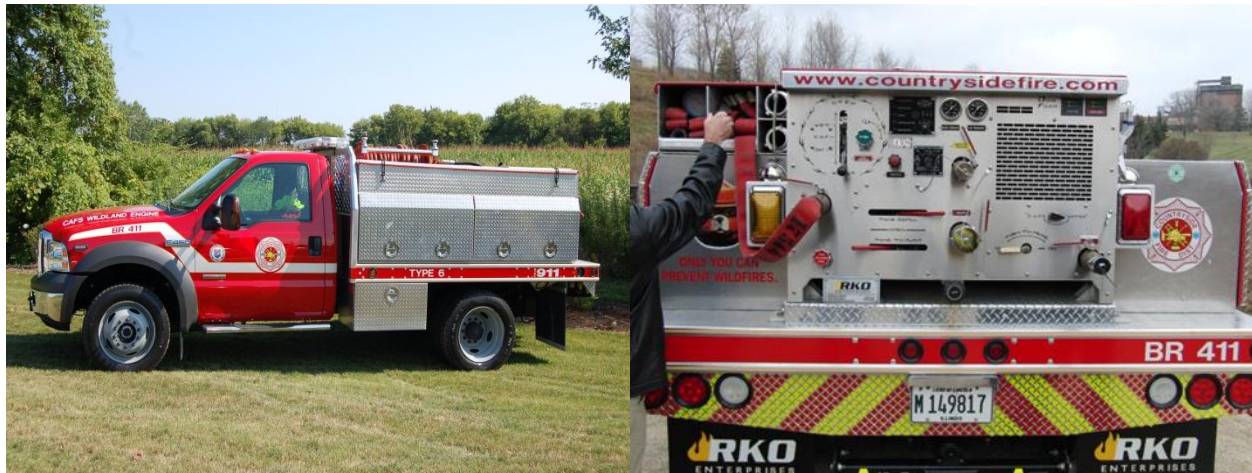
Figure 43 Fire truck with compressed air foam system

For this experiment, a Class A foam concentrate used in a 1% concentration with a compressed air foam system (CAFS) was applied to two different PV systems to determine the effectiveness of foam in blocking illumination and reducing or eliminating the electric shock hazard. Figure 43 illustrates the CAFS foam truck.

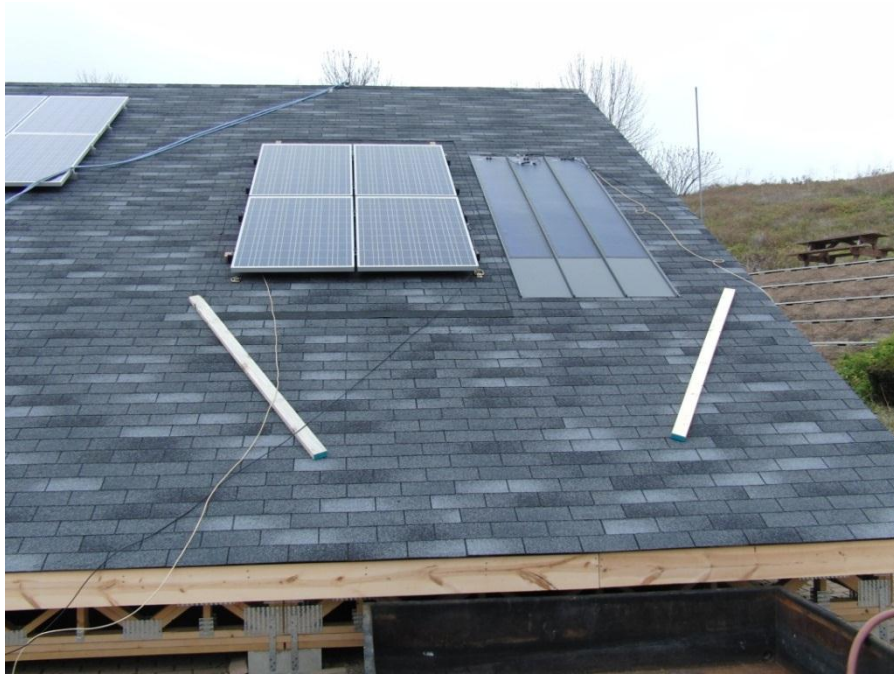
Figure 44 Test roof with four-framed module and three-laminate arrays

The two PV systems used were 1) the four framed-module array used above in the experiments with tarps, and 2) a three-laminate array. The laminates consisted of PV laminate modules mounted to metal pans (18 inches on center) typical of a standing seam metal roof construction. Each laminate was rated 68 watts (P_{max}), with 23.1 V open circuit (V_{oc}), 5.1 A short-circuit current (I_{sc}). Three laminates were wired in series, and at standard test conditions, the output of the three-laminate array would be approximately 69 volts open circuit, 5 amps short circuit. Figure 44 illustrates the PV test specimens prior to application of foam.

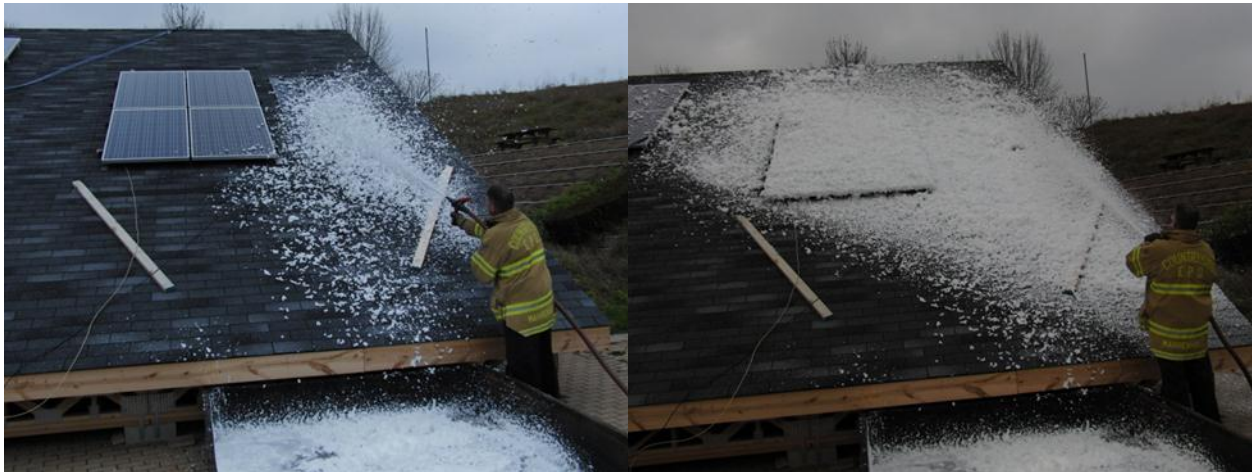
Figure 45 Applying Class A foam (1%) with compressed air foam system

Weather conditions at the time of these experiments were cloudy, with a solar irradiance of only 20 - 60 W/m², and a temperature of 7 °C. At the beginning of the test, and before any foam was applied, the four-framed module array had an open circuit voltage of 136 volts DC, and with the three-laminate array the open circuit voltage was 63 volts DC, measured with a solar irradiance of 60 W/m². The Class A foam (1%) was applied approximately 1 – 3 inches over the full exposed surface area of the modules and laminates. Figure 45 illustrates the PV test specimens during the application of foam.

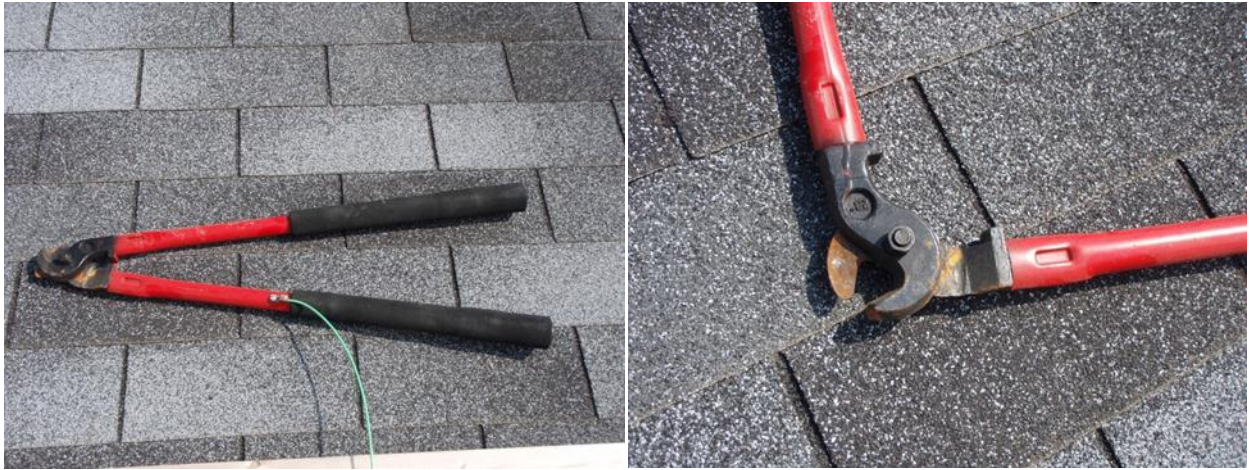
Figure 47 Cable cutter

Cable Cutter (Figure 47) – The cable cutter was 28 inch, with a 1-1/4 inch jaw capacity. The cable cutter was metal, and the handles were provided with non-metallic grips, however these grips were described as for providing comfort and no claims were made about electrical insulation. For test purposes, a wire connector was connected to the metal portion of the cutter to provide connection to a wire that would represent a firefighter coming in contact with the metallic conductive portion of the cutters. Figure 47 illustrates the cable cutter modified to include an electrical terminal for grounding.

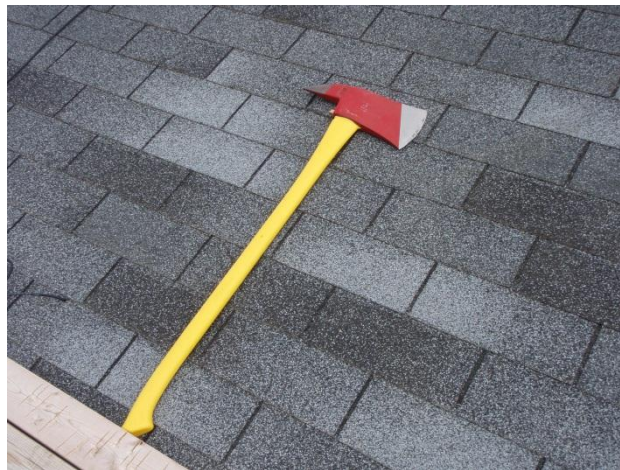
Figure 48 Fiberglass handle axe

Axe (Figure 48) – The axe was 36 inch, with a fiberglass handle that was described as “will not conduct electricity.” For test purposes, a wire connector was connected to the metal blade to provide connection to a wire that would represent a firefighter coming in contact with the metallic blade portion of the axe Figure 48 illustrates the axe used in the experiments.

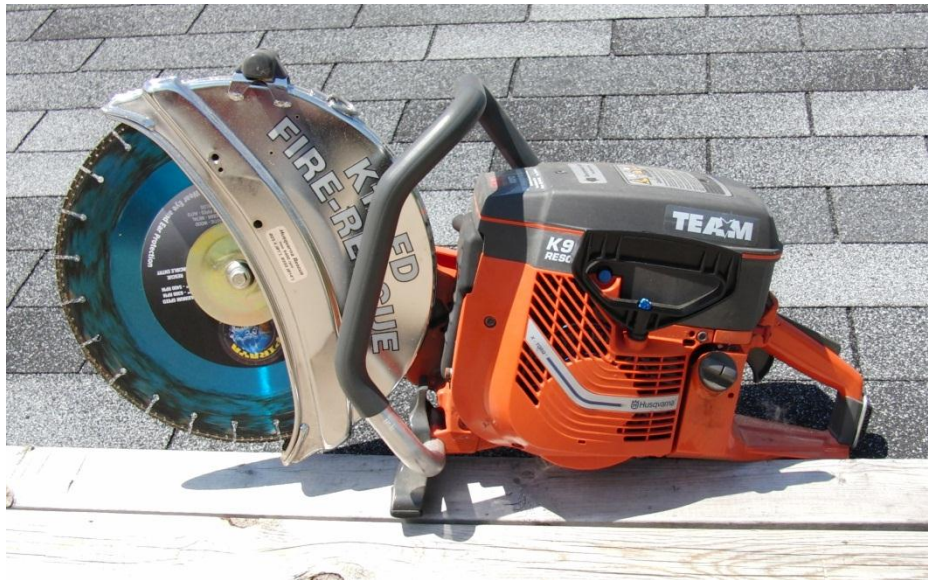
Figure 49 Rotary saw

Rotary Saw (Figure 49) – The circular saw was a 14 inch fire rescue type saw with a metal diamond blade installed. For test purposes, a wire connector was connected to accessible metal hardware on the saw that was electrically continuous to the saw blade. This provided connection to a wire that would represent a firefighter coming in contact with the metallic portions of the saw that were electrically continuous to the blade. Figure 49 illustrates the rotary saw used in the experiments.

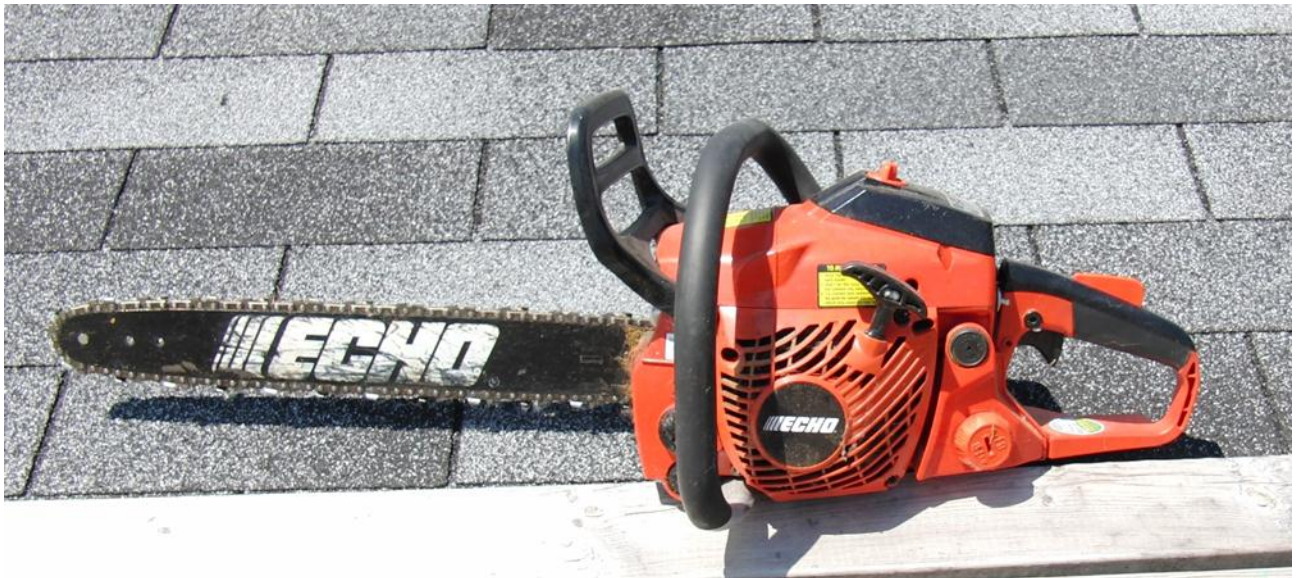
Figure 50 Chain Saw

Chain Saw (Figure 50) – The chain saw was a gas power chain saw with a standard 14 inch wood cutting chain. For test purposes, a wire connector was connected to accessible metal hardware on the saw that was electrically continuous to the saw chain. This provided connection to a wire that would represent a firefighter coming in contact with the metallic portions of the saw that were electrically continuous to the chain.

The source of PV power for these experiments was the test array described in Sec. 5.3 with modules wired in series to produce 1000 V open circuit, and 8 A short circuit. The negative side of the array was connected to ground, and also in the grounded negative side was a 500 Ohm resistor to represent a body impedance, and a metering shunt to measure current. A lead from the negative was also connected to the tool being used for the cutting through the wire connector as described above. Figure 50 illustrates the chain saw used in the experiments.

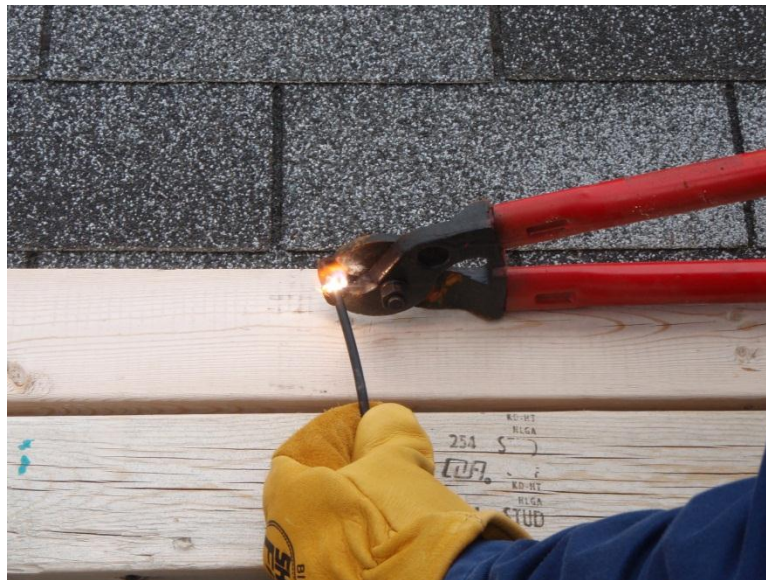
Figure 51 Cutting wire with cable cutter

For this experiment, the cable cutters were used to sever an exposed wire, Type USE-2, No. 10 AWG, which was connected to the positive side of the 1000 V array. For the first test, a slow cut was made through the wire with the cutters. This produced a current in the circuit of 2 A.

For the second experiment, this first experiment was repeated, but with making a fast cut through the wire with the cutters. This produced a current in the circuit of 2 A for about 200 milliseconds, and the current reduced to zero by 300 milliseconds. Figure 51 illustrates arcing to grounded cable cutter.

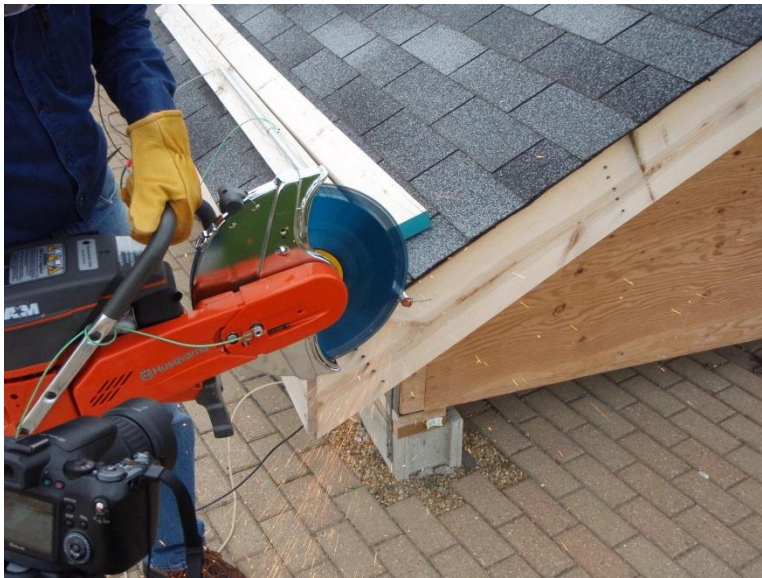
Figure 53 Rotary saw cutting through EMT

For this experiment, the rotary saw was used to sever a metal raceway, ½ inch electrical metallic tubing (EMT) with a No. 12 AWG copper Type THHN wire installed within. The No. 12 AWG wire was connected to the positive side of the 1000 V array, and the metal tubing was connected to ground. Attempting to measure current with this experiment with the rotary saw presented challenges due to the intense electrical noise being produced by the engine. However, in this scenario with the ungrounded positive conductor inside the grounded metal raceway, the current had two paths, one through the grounded wire connected to the saw and 500 Ohm resistor to represent the firefighter, and the other through the grounded metal tubing Figure 53 illustrates rotary saw cutting through EMT.

Experiments showed that in a scenario such as cutting energized wires, current sufficient to cause a dangerous electric shock. The length of time this current was present was often shortened because of the complete severing of the wire. This could eliminate some potential hazards, such as lock-on and the inability to let go. Some firefighting operations also require roof ventilation and the use of a cutting tool such as rotary saw or chain saw to cut through the roof decking material. A hazard could exist if the firefighter is not aware of energized conductors, such as PV wires installed in metal raceways in the attic, are present. Although the firefighter operating these tools is not often in contact with a metal portion of the tool that may become energized when contact with the energized conductor is made, these tools are not typically tested for their electrical insulation properties. Experiments also showed that energized PV conductors of opposite polarity are in the same raceway and severed, after the cutting takes place it is possible for the arcing to continue and result in open flaming and ignition of materials. A chain saw also poses the risk of exposing live conductors from the ripping and pulling action of the chain against the wire.

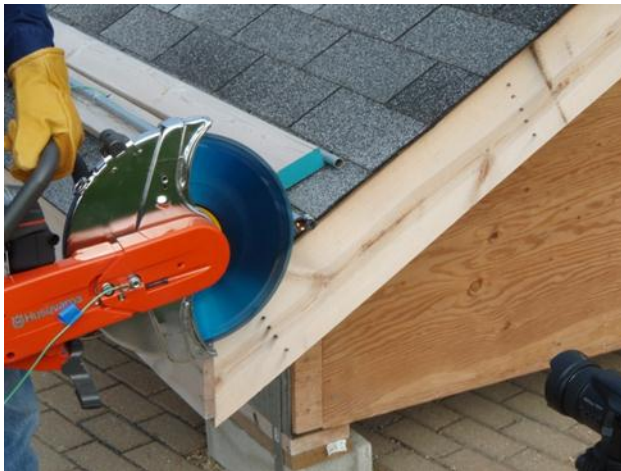
Figure 54 Cutting through nonmetallic conduit

For this second experiment, the rotary saw was used to sever a non-metallic conduit, ½ inch Type PVC, with two No. 12 AWG copper Type THHN wires, one positive and one negative, installed within. Cutting through the nonmetallic conduit produced a current of 8 A. In this scenario there was no path to ground through a metal raceway. After the cut was made, arcing continued between the positive and negative conductors, resulting in an open flame. Figure 54 illustrates rotary saw cutting through nonmetallic conduit. Figure 55 illustrates ignition of the nonmetallic conduit.

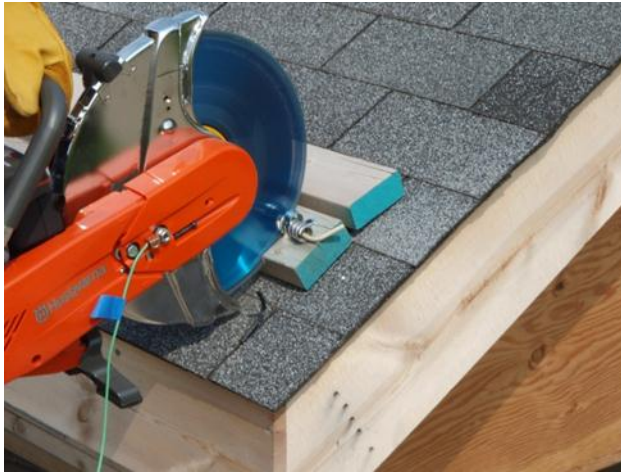
Figure 56 Cutting through flexible metal conduit

For this third experiment, the rotary saw was used to sever a flexible metal conduit, ½ inch Type FMC, with two No. 12 AWG copper Type THHN wires, one positive and one negative, installed within. The flexible metal conduit was secured to a wood stud. After the cut was made, arcing continued between the positive and negative conductors, resulting in ignition of the wire insulation and the wood stud to which the flexible metal conduit was attached.

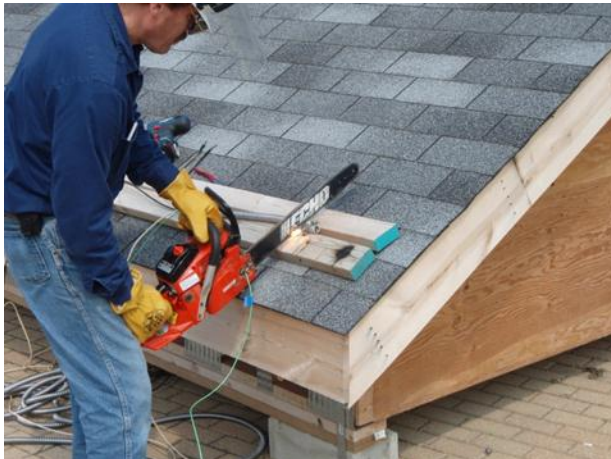
Figure 58 Cutting through flexible metal conduit

For this fourth experiment, the chain saw was used to sever a flexible metal conduit, ½ inch Type FMC, with two No. 12 AWG copper Type THHN wires, one positive and one negative, installed within. After the cut was made, arcing continued between the positive and negative conductors, resulting in an open flame igniting the wire insulation and the wood stud to which the flexible metal conduit was attached. It was also noted that the rotating chain of the saw ripped the conductor out of the flexible armor, resulting in an exposed conductor after the cut was made. Figure 58 illustrates the chain saw cutting through flexible metal conduit. Figure 59 illustrates ignition as a result of the severing of the conductors.

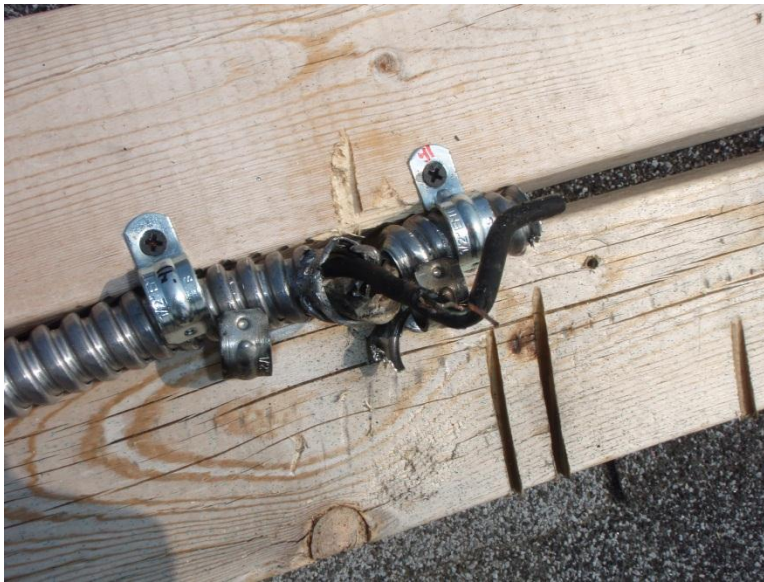
Figure 60 Exposed conductor from action of chain cutting

Figure 60 illustrates the exposed conductors resulting from the chain saw severing the conduit.

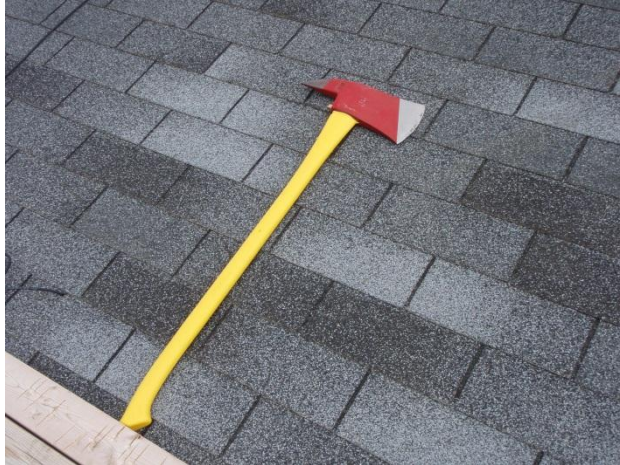
Figure 62 Fiberglass handle axe

Axe – The axe was 36 inch, with a fiberglass handle that was described as “will not conduct electricity.” For test purposes, a wire connector was connected to the metal blade to provide connection to a wire that would represent a firefighter coming in contact with the metallic blade portion of the axe. Figure 62 illustrates the axe used in the experiments.

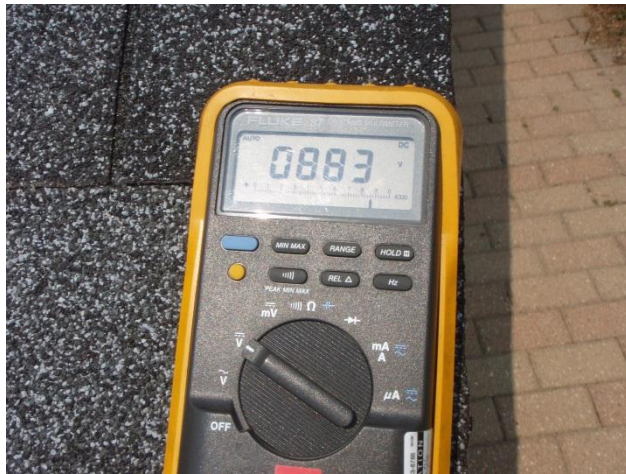
Figure 67 Voltage measured between metal pan and earth

Figure 67 illustrates the voltage measured during the experiment.
