Firefighter Safety and Photovoltaic Installations Research Project

Issue Date: November 29, 2011

EXECUTIVE SUMMARY

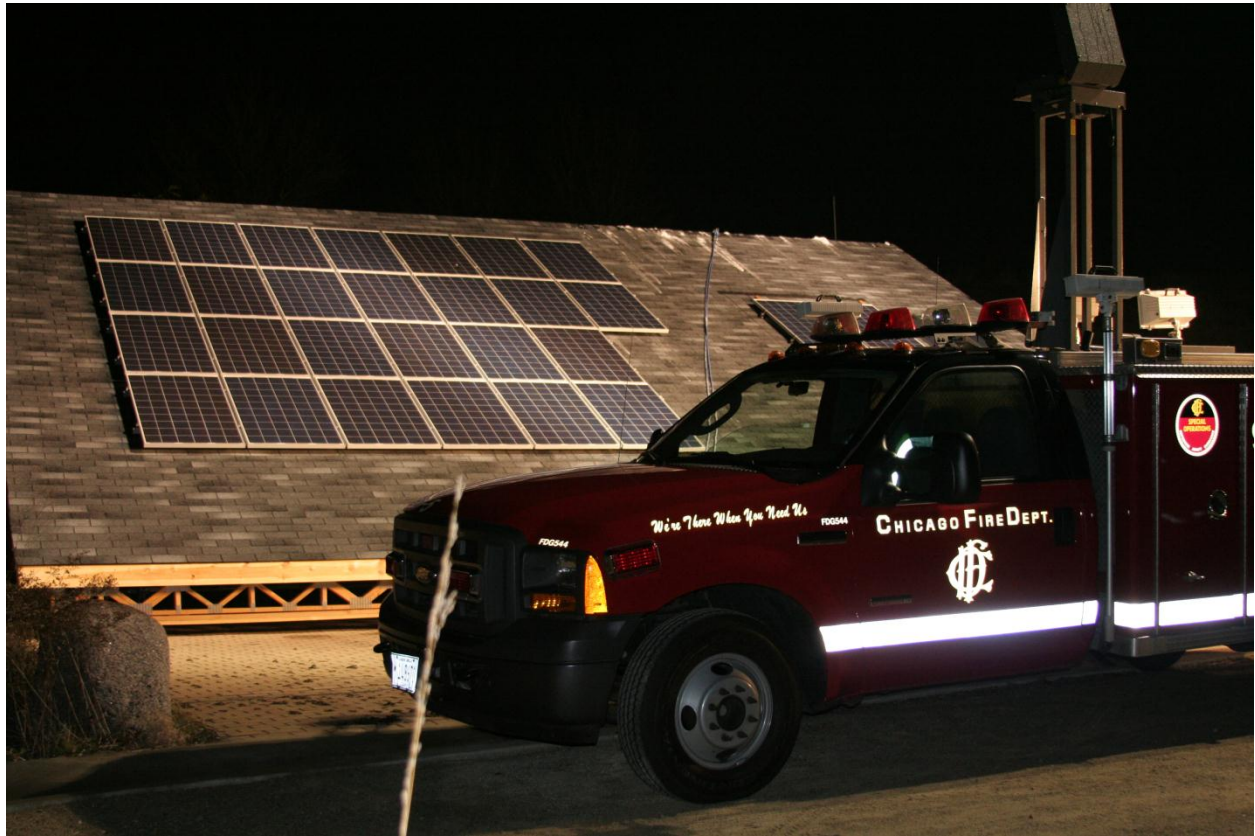
Figure 70 - Array being illuminated by Light Truck No. 1

A series of experiments was conducted by using either Truck No. 1 or No. 2, or both, with all or some of their lighting illuminated. Measurements of the array's open circuit voltage and short circuit current were made with the trucks' at various distances from the array. Distance was measured from the edge of the truck to the front edge of the array, with the front edge of the array only a few feet above grade. Truck No. 1 was positioned 25 and 50 feet from the array depending on the experiment. At 25 feet, Truck No. 1 was positioned in front of the array, and at 50 feet, Truck No. 1 was at about a 45 degree angle from the array.

Truck No. 2 was positioned 38 and 75 feet from the array depending on the experiment. At 38 feet, Truck No. 1 was positioned in front of the array, and at 75 feet, Truck No. 2 was at about a 45 degree angle from the array. Figure 70 illustrates array illuminated by Fire Department light truck.

Artificial Light from a Fire Truck - In most cases under these artificial lighting conditions, the light trucks were able to produce enough illumination to cause an electrical shock hazard. Although significantly less than the 240 milliamp threshold for ventricular fibrillation of the heart, both of the trucks were each able to produce enough light to cause the array to produce over 40 milliamps, the "lock-on" threshold, even at distances as far away as 38 feet from the array.

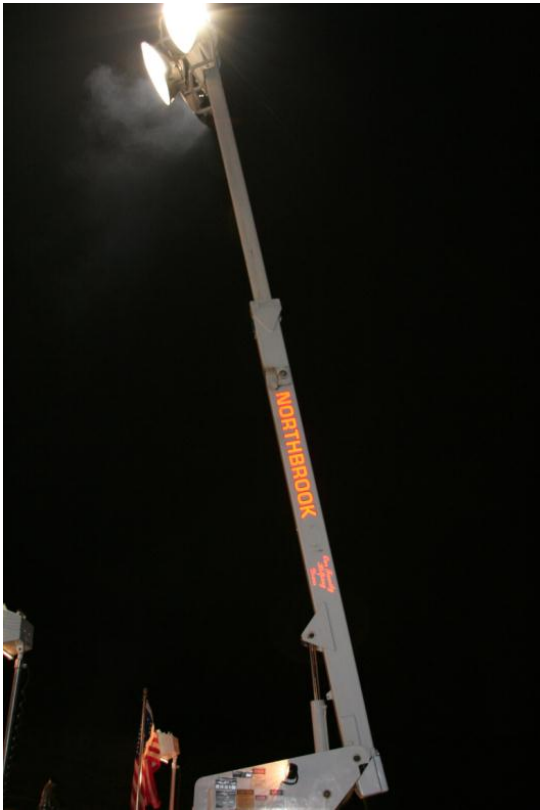
Figure 71 Light Truck No. 2 boom lights

Figure 71 illustrates Fire Department light truck boom mounted lights.

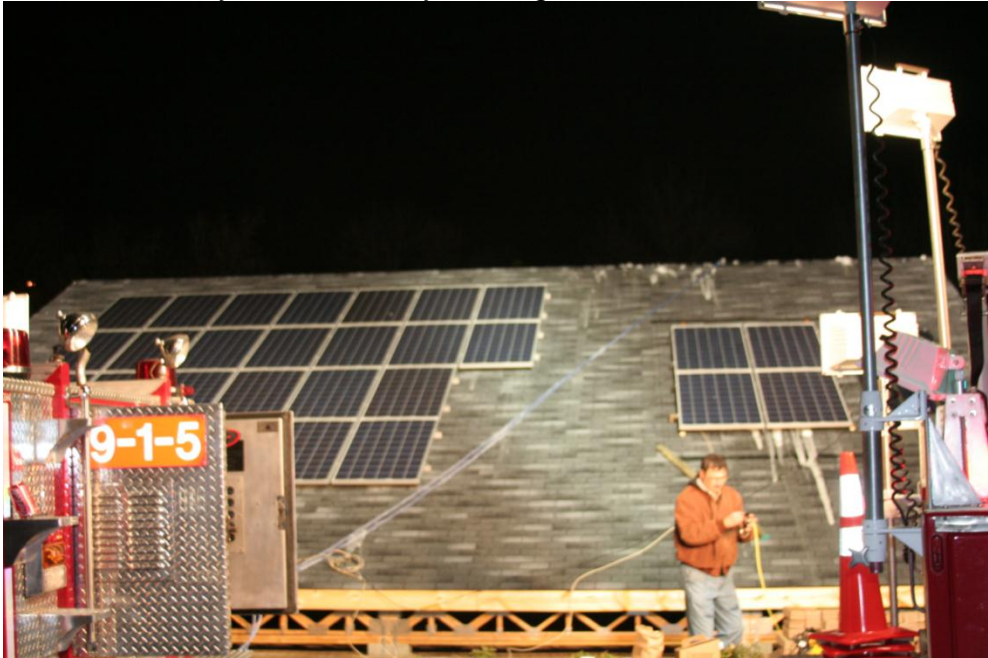
Figure 72 Both trucks lighting the array

Figure 72 illustrates array illuminated by both light trucks, boom and bed mounted lights.

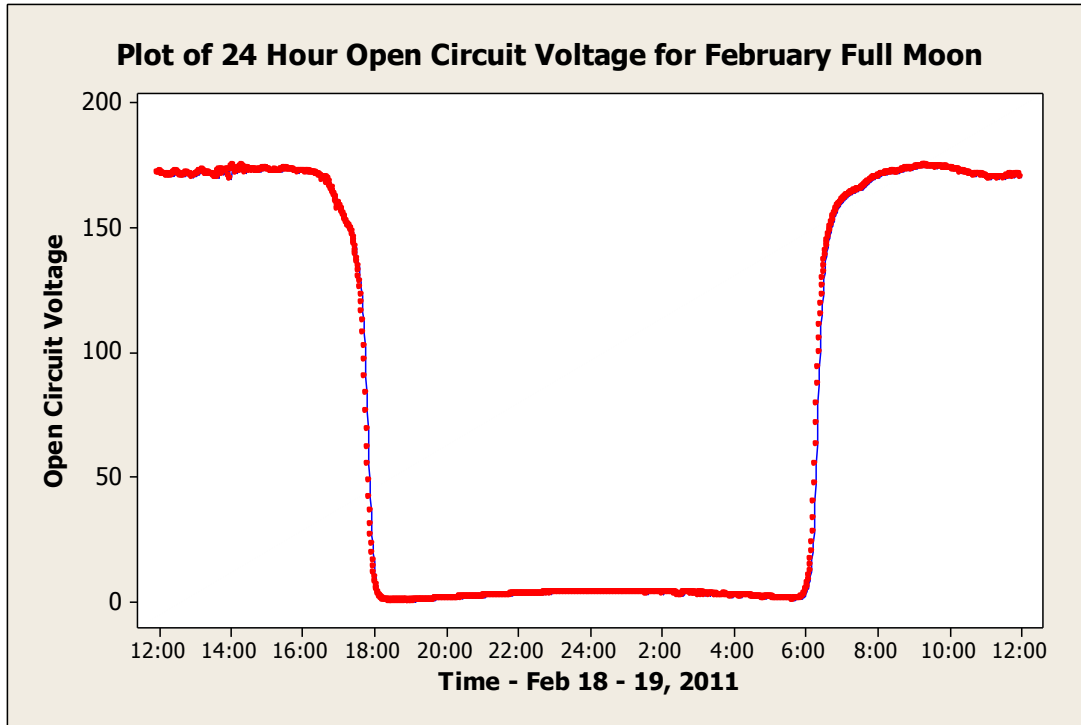
Figure 74 Plot of array open circuit voltage for 24 hour period with full moon

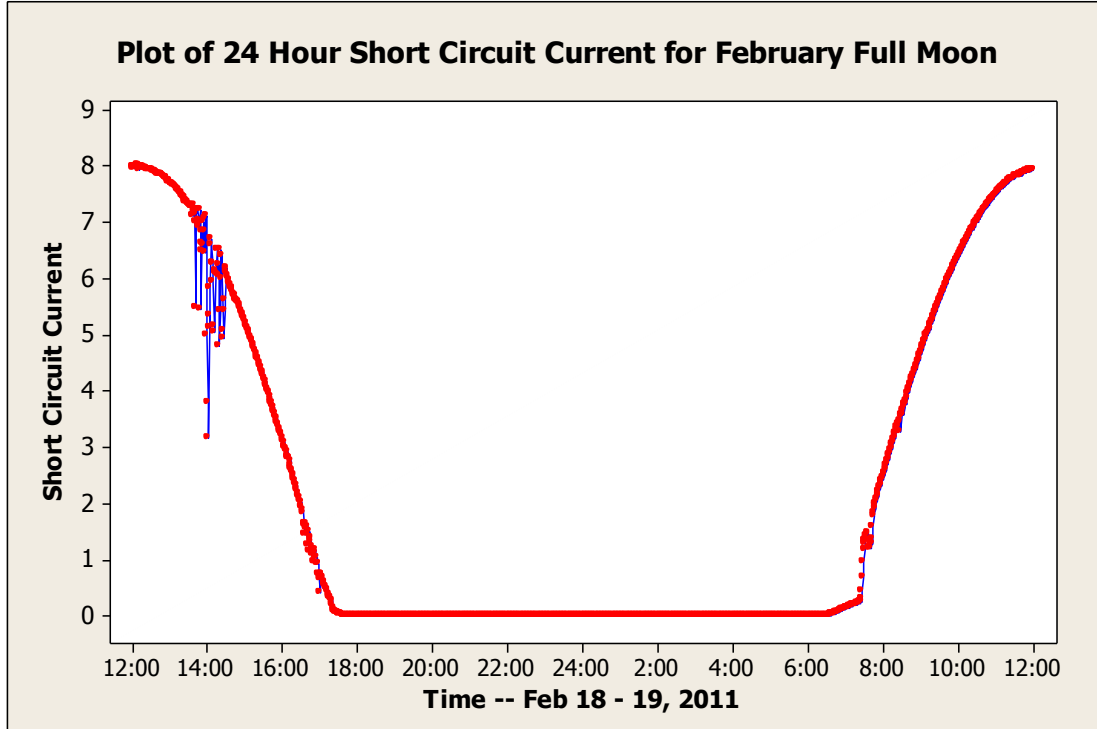
Figure 75 Plot of array short circuit current for 24 hour period with full moon (scattered clouds noted from 13:00 – 15:00 hours on plot)

moon. Figure 75 illustrates the short circuit current for for a 24 hour period during a full moon.

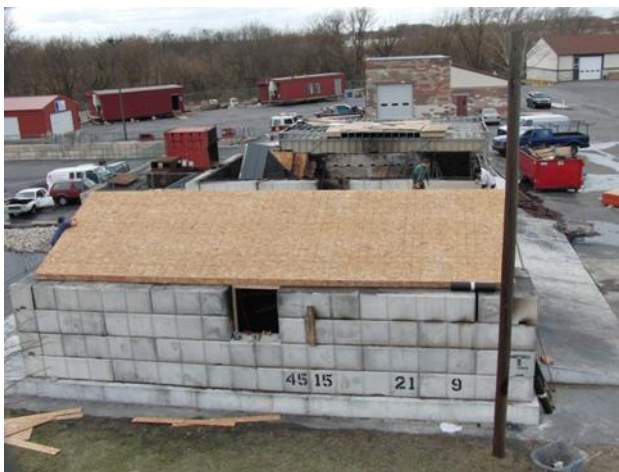
Figure 76 Test bunker – side with window opening

A series of experiments were conducted at the Delaware County Emergency Services Training Center in Sharon Hill, PA. Two concrete bunkers, each measuring 36 by 21 by 8 feet high were built on a concrete slab. A wood truss roof was then constructed on each bunker; with a resulting surface area of approximately 36 by 12 feet per side with a 5/12 pitch. The bunker had provisions for door and window openings on three sides which could be closed with cement board for test purposes. Figure 76 and Figure 77 illustrate the test fixture for the full scale array fire experiments.

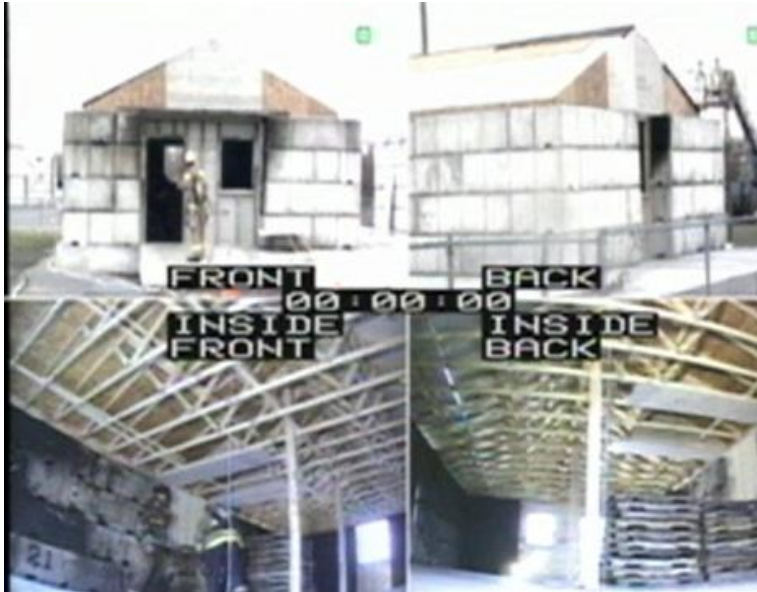
Figure 81 Quad Video 1 - Compartment / Roof Fire

earlier with two additional views recording the area under the rack mounted array. Both cameras were positioned along the centerline of the roof, one view from the ridgeline forward to the edge of the roof, one from the front of the structure looking toward the rear. Figure 81 illustrates a quad video view of the room of content fire experiments. Figure 82 illustrates a quad video view of the debris fire under array experiments.

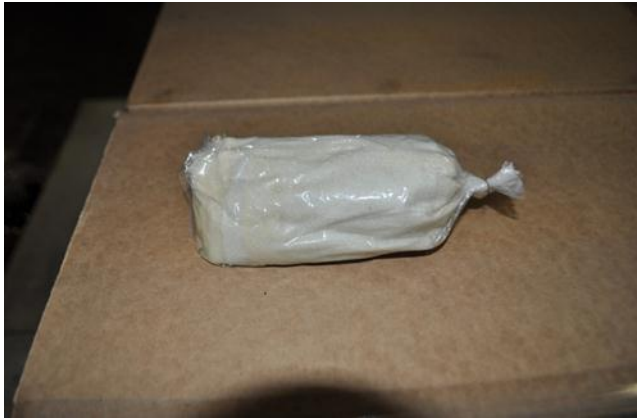
Figure 83 UL Igniter

The fuel packages was located in the center of the structure and biased to the left wall. Figure 61 shows the relative locations of the fuel packages. The center of the fuel package was located 9 ft from the end walls and 10 ft from the side walls. The fire was ignited with two standard UL igniters made up of gauze in a plastic bag, soaked in 8 ounces of gasoline. Each igniter weighed 0.5 lb., and they were placed in the separation of the pallets with one in each stack, on opposite sides. To light the igniters a torch was touched to them. The fire grew and was allowed to burn until the structural integrity of the roof assembly was compromised at which time it was extinguished. The igniters were lit remotely with a thin wire wrapped around a pack of matches that was electrically charged until the heat from the wire ignited the matches and in turn ignited the igniters. Figure 83 illustrates the UL igniter. Figure 84 illustrates the position of igniter within the wood skid fuel package.

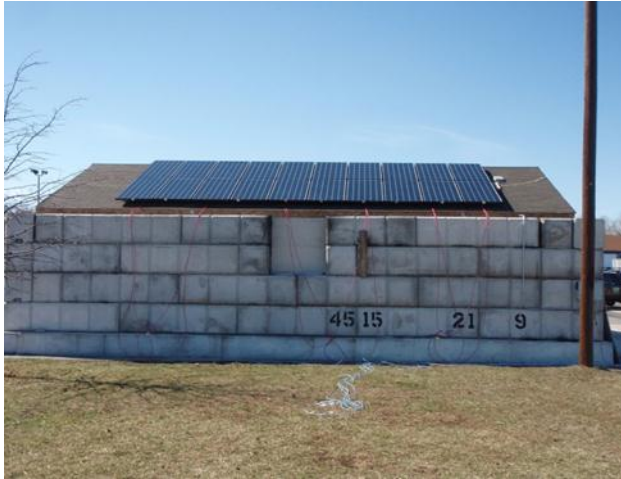
Figure 85 Completed framed module array

Figure 85 and Figure 86 illustrate the PV array mounted on the test structure. Figure 87 illustrates the installation of the metal framed modules. Figure 88 illustrates the

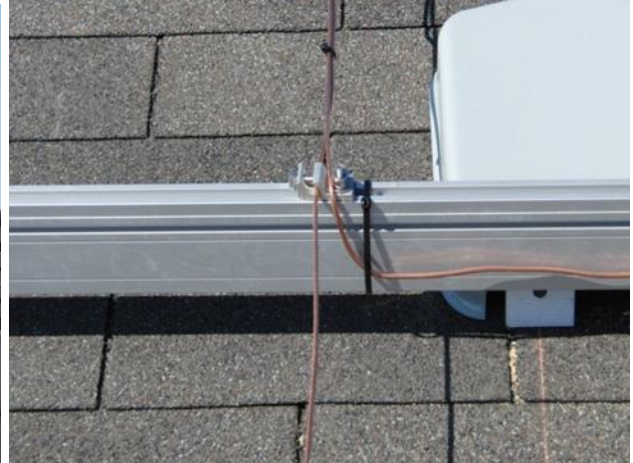
Figure 88 Grounding system for rails

grounding method of the array. Figure 89 provides a view of the raised, rack mounted array and combiner box.

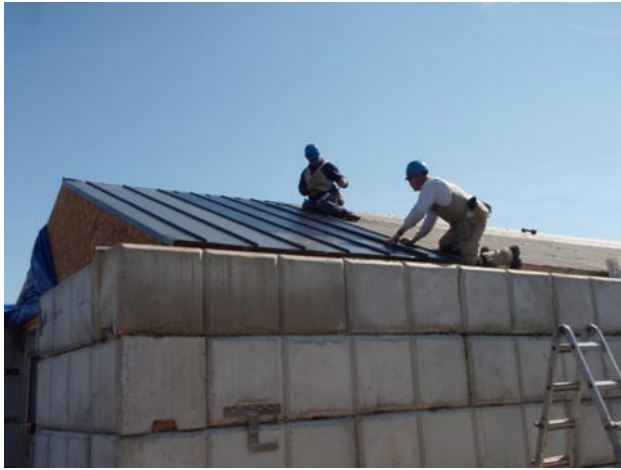
Figure 90 Installing laminates and metal roof

Figure 90 illustrates the installation of the laminate PV / standing seam metal roof. Figure 91 illustrates the completed installation of the laminate PV / standing seam metal roof array. Figure 92 illustrates the wiring method. Figure 93 provides a view of the inverter location on the test structure.

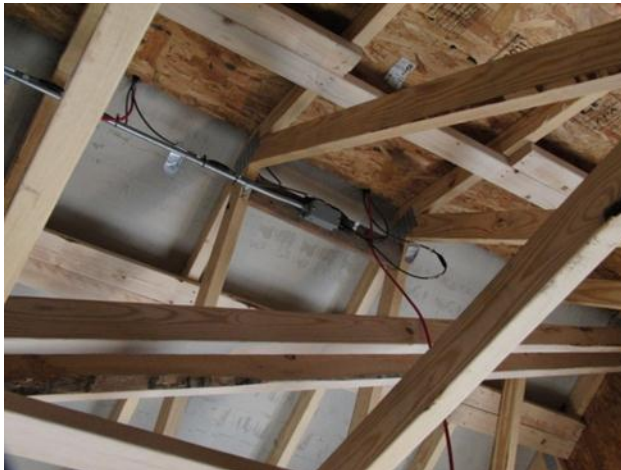
Figure 92 Laminate lead wires and home run

The leads from the junction box of the laminates were wired on the inside of the roof. The “home run” wire was installed in electrical metallic tubing (EMT) mounted along the inside of the roof near the peak. The PV array was wired through a disconnect switch to an inverter rated 4000 watts, and located on the side of the bunker near ground level. The inverter was connected to a 208 volt ac, single phase grid tie. The DC PV system was negative grounded, and the metal pans were not connected to equipment ground. For test purposes, voltage sense leads were attached to the laminate leads to measure individual laminate output voltage during the test, as well as the measurement of array voltage and array current at the inverter.

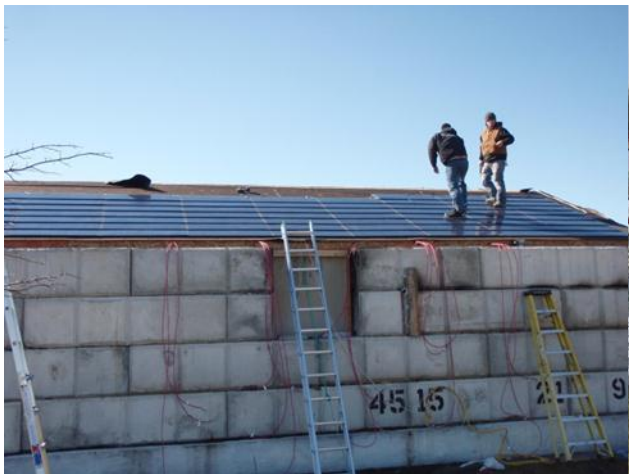
Figure 94 Installing solar shingles

The shingles were secured to the roof with screws. The roof surface under the modules consisted of $\frac{3}{4}$ inch OSB decking covered with 15 lb felt paper. The other half of the roof was decked with cement board to help force the fire to burn through the PV side of the roof.

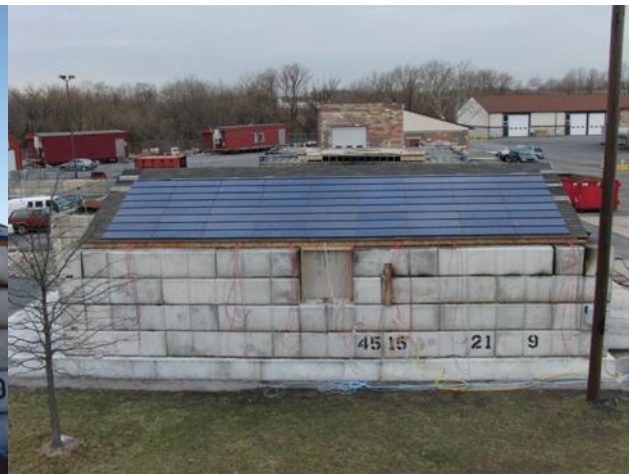
Figure 95 Overhead view of shingle roof

The leads from the junction box of the shingles, and the home run wire, were routed within the integral shingle wireway. The PV array was wired through a disconnect switch to an inverter, rated 4000 watts, and located on the side of the bunker near ground level. The wires from the PV array on the roof to the inverter were installed in EMT. The inverter was connected to a 208 volt ac, single phase grid tie. The DC PV system was negative grounded, and there were no connections to an equipment ground. For test purposes, voltage sense leads were attached to the solar shingle leads to measure individual shingle output voltage during the test, as well as the measurement of array voltage and array current at the inverter. Figure 94 illustrates the installation of the solar shingle modules. Figure 95 provides a view of the completed solar shingle array. Figure 96 illustrates the solar shingle.

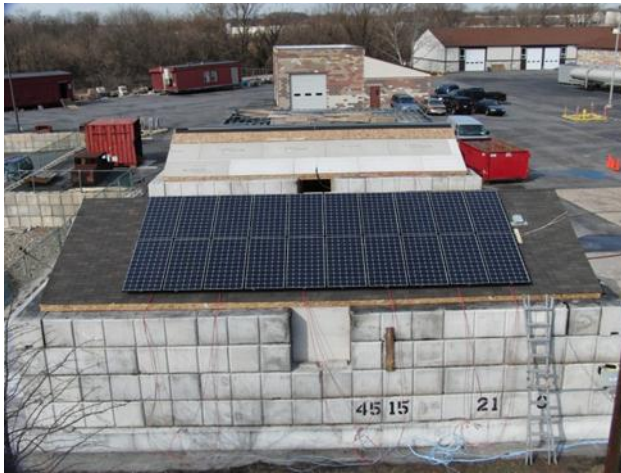
Figure 97 Pre-Test conditions with modules

Figure 97 provides a view of the test array prior to the start of the experiment. Figure 98 illustrates the interior of the test building. Figure 99 provides a view of the door and window during the experiment. Figure 100 illustrates smoke venting from the test structure.

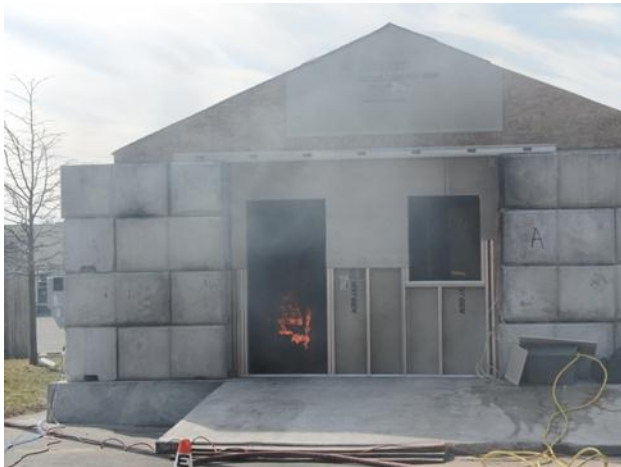
Figure 99 Wood pallets fully engulfed in flames

After 2 minutes (elapsed time), the pallets were fully engulfed in flames, and some smoke was observed coming out the door and window. After 4 minutes some smoke was observed under the panels, but there was no breach in the roof. At 6 minutes 40 seconds, the ground-fault detection and interruption fuse within the inverter opened, and the inverter turned off. The density of the smoke continued to increase, and after 9 minutes 30 seconds some flames were observed coming from the top of the roof. At 12 minutes there was open flaming at the back gable end, and at 13 minutes some water was applied at that location to help force the fire towards the center of the roof structure. At 16 minutes there was some horizontal sag observed in the modules between the upper and lower strings, and at 17 minutes flames breached completely through the roof. At 18 minutes 30 seconds, the roof and PV array collapsed into the building, and water was applied to extinguish the fire.

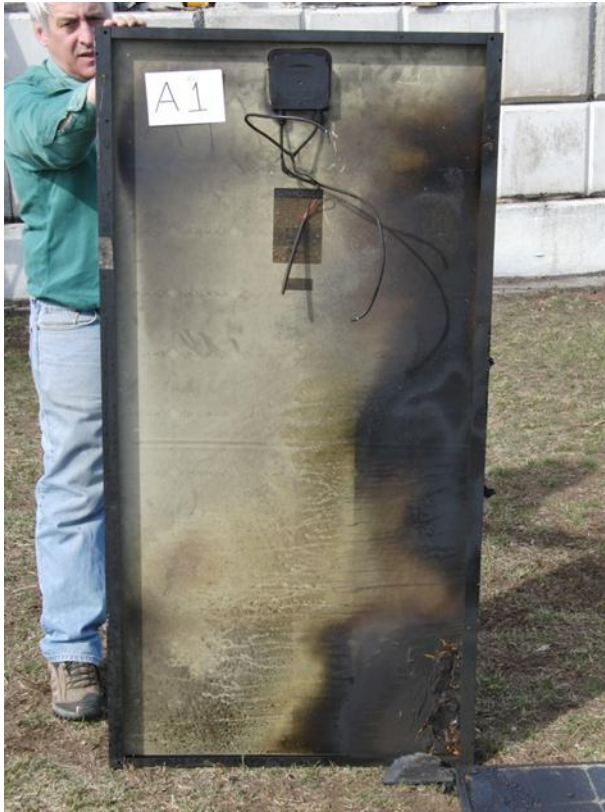
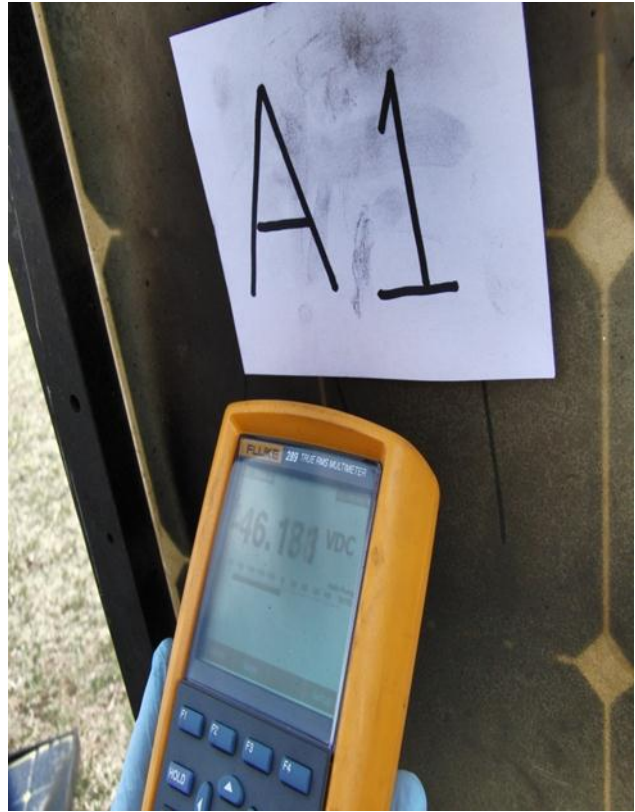
Figure 115 Module A1 – damaged but functional and producing full voltage

Figure 115 through Figure 120 illustrate damaged but functioning modules.

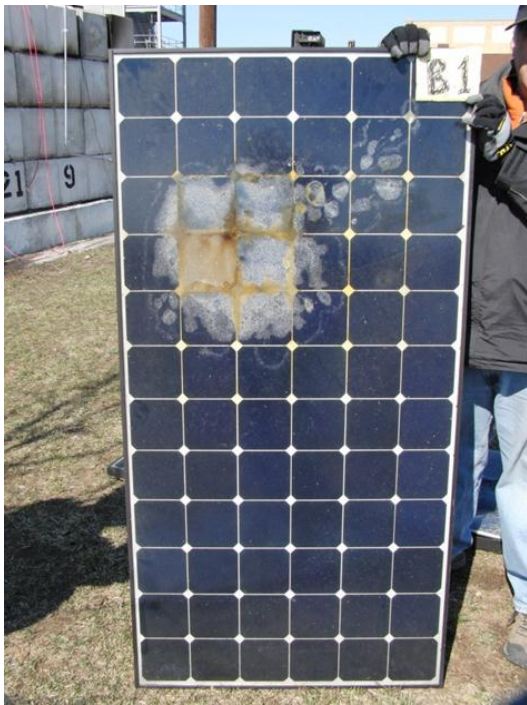
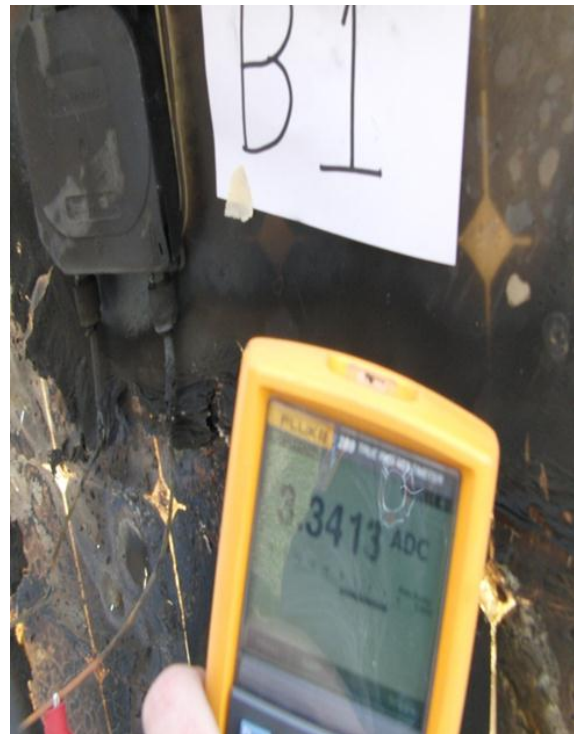
Figure 116 Module B1 – damaged but still producing over 3 amperes

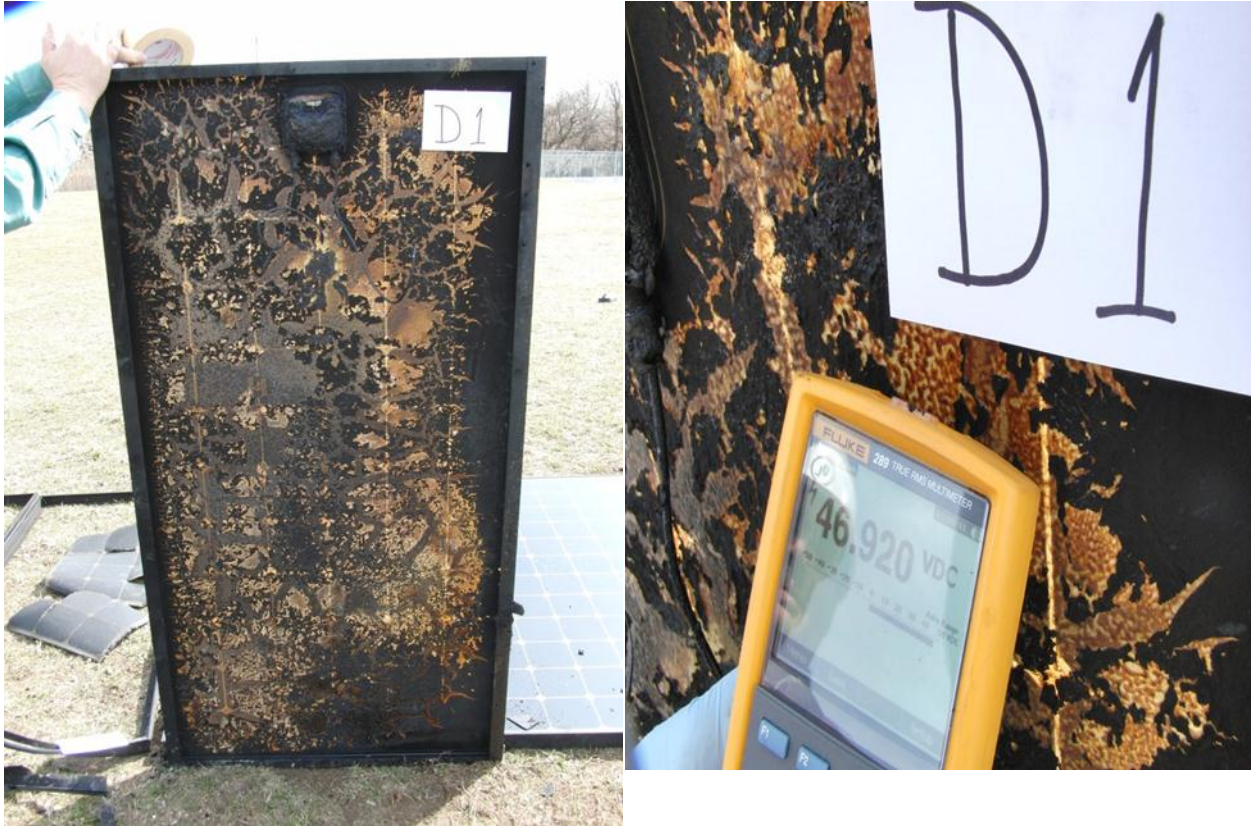
Figure 117 - Module D1 – badly burnt on backside, but functional and producing full voltage

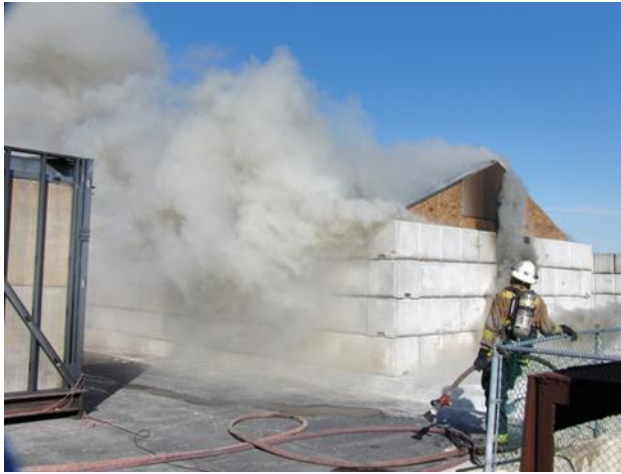
Figure 123 Smoke developing

Figure 123 through Figure 126 illustrate increasing fire and smoke conditions during the experiment.

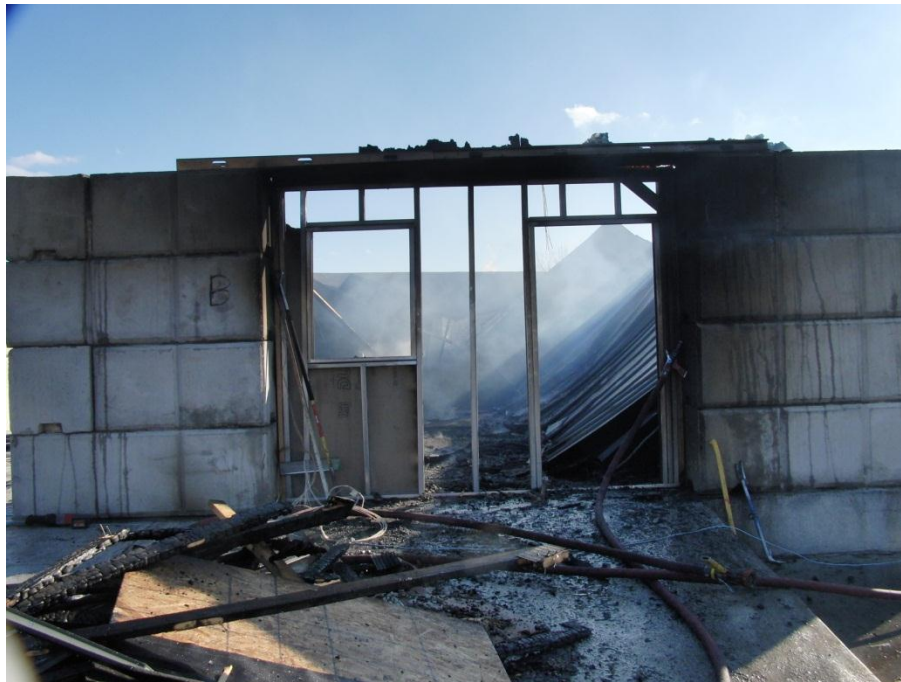
Figure 127 Collapsed roof and laminates

Figure 127 and Figure 128 provide a view of the condition of the PV laminate and metal roof after collapse of the structure.

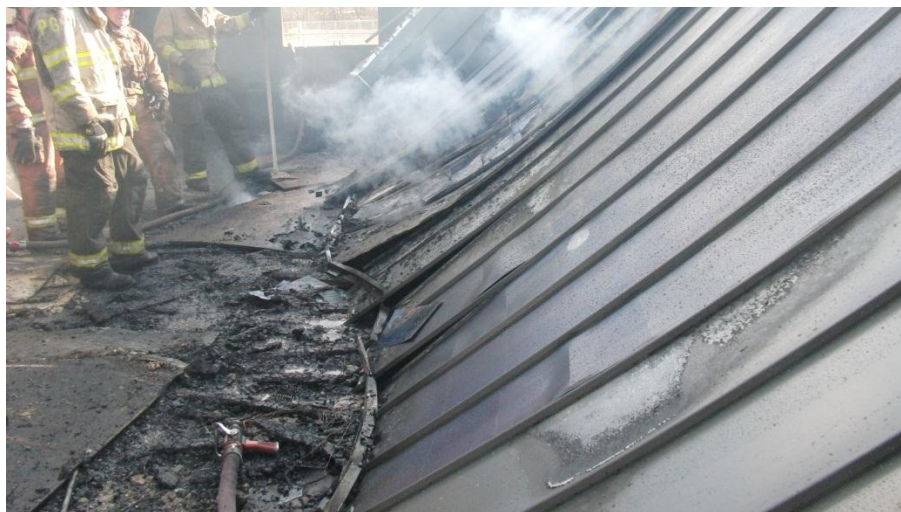
Figure 128 Firefighters approaching Collapsed Laminates after Fire

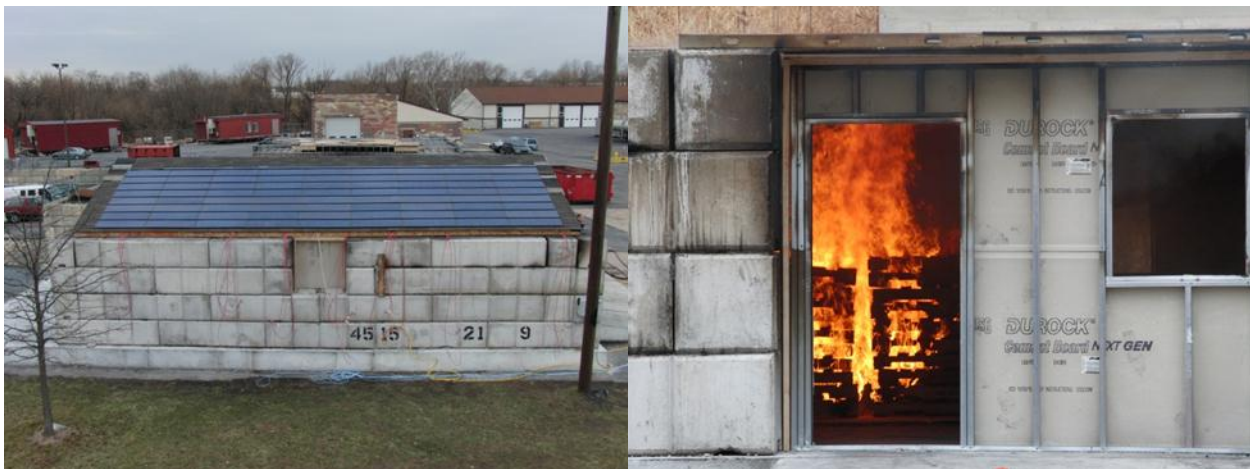
Figure 142 Pre-test conditions with shingles

Figure 143 Wood pallets engulfed in flames

Figure 142 provides a view of the PV shingle array prior to the experiment. Figure 143 illustrates the burning of wood skid fuel package.

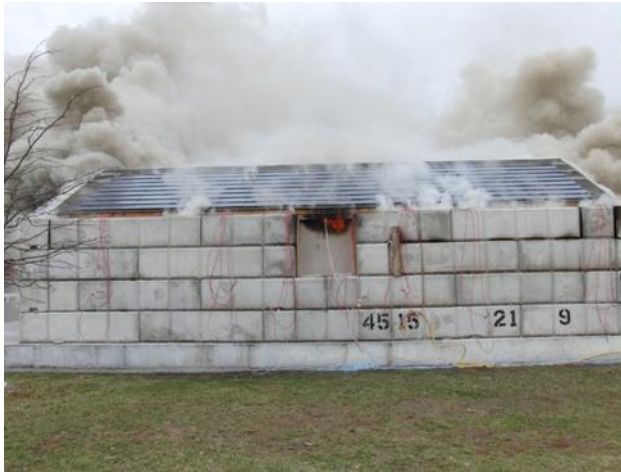
Figure 144 Smoke rising from roof

Figure 144 through Figure 147 illustrate the developing smoke and fire conditions prior to structural collapse.

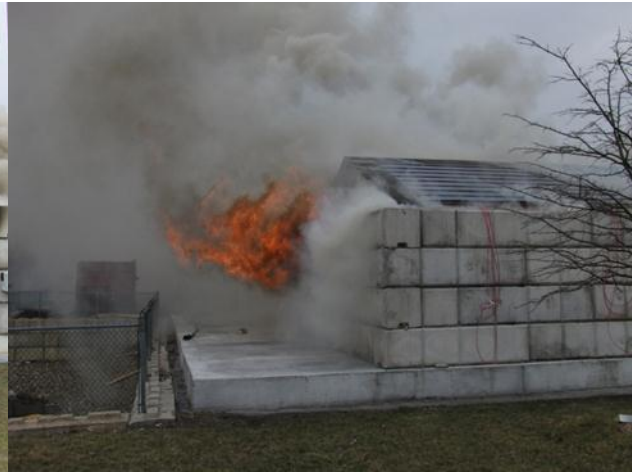
Figure 145 Flames from backside of roof

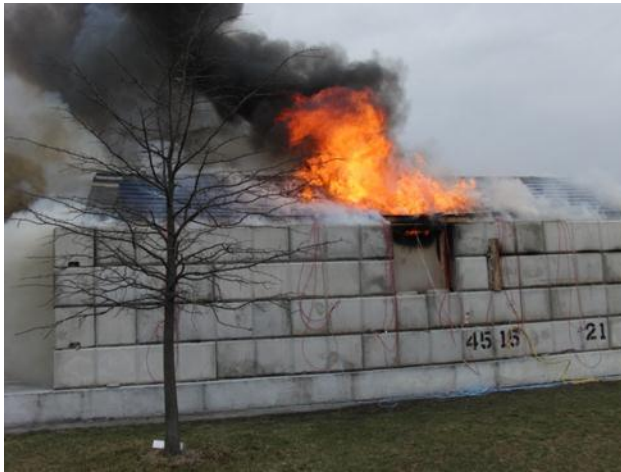
Figure 146 Solar shingles on fire

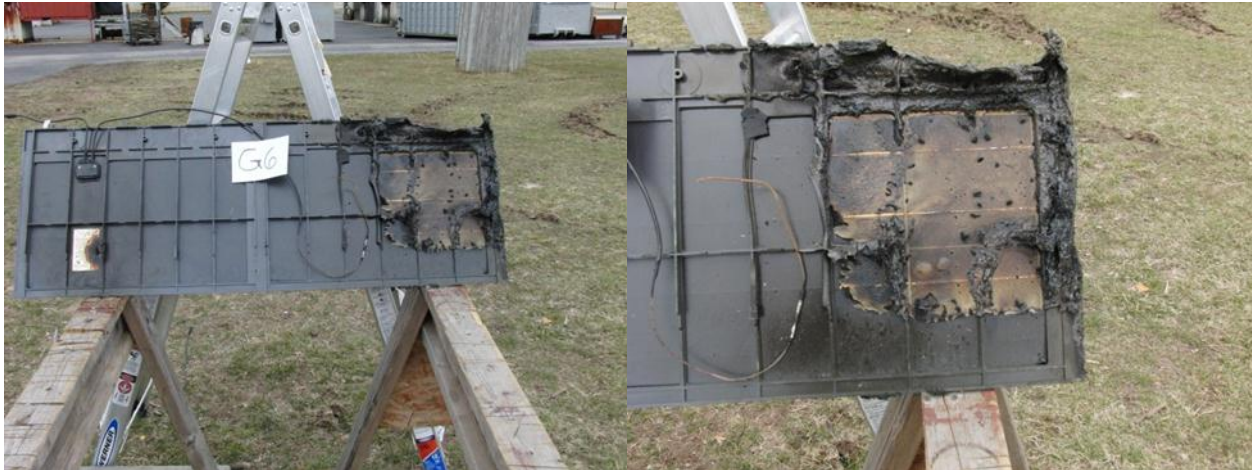
Figure 160 Damaged shingle G8, exposed conductors and bus - fully functional

Figure 159 and Figure 160 provide a view of a damaged module which continued to generate power.

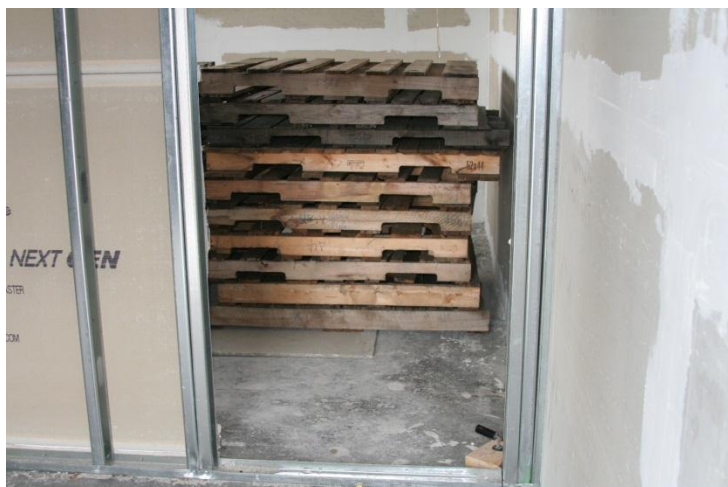
Figure 161 Photograph of wood skid fuel package in room.

The fire load consisted of 20 wood pallets, stacked in two rows of 10 each. The wood pallets were located at ground level inside the bunker at the approximate center of the roof under the PV modules and adjacent to an opening, to represent a window, located on the east side of the bunker. These wood pallets were positioned in a small compartment within the bunker that was sheathed with cement board on all sides to help confine the fire to that space and force the fire to vent out through the adjacent window. In addition, the compartment ceiling prevented fire spread into the attic and protected the wood truss construction. The total weight of the 20 wood pallets was 795 lbs.

Figure 161 illustrates the fuel package within the gypsum

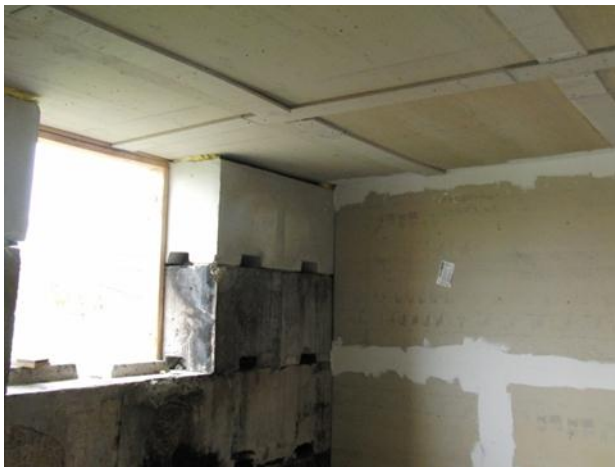
Figure 162 Confined ignition space in bunker

Figure 162 provides a view of the window vent from the compartment. Figure 163 through Figure 166 illustrate the fire existing the window vent.

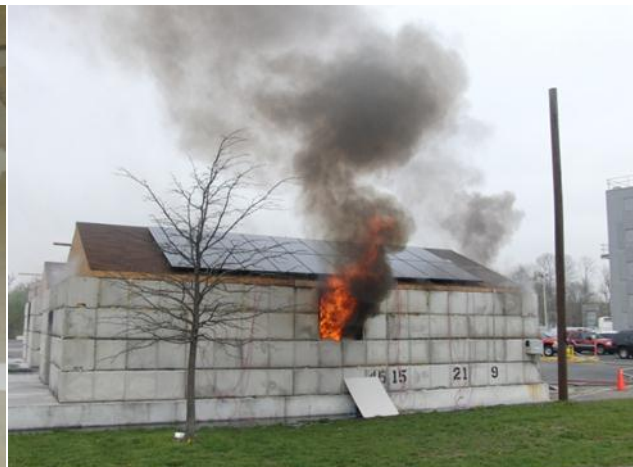
Figure 163 Flames forced out window opening

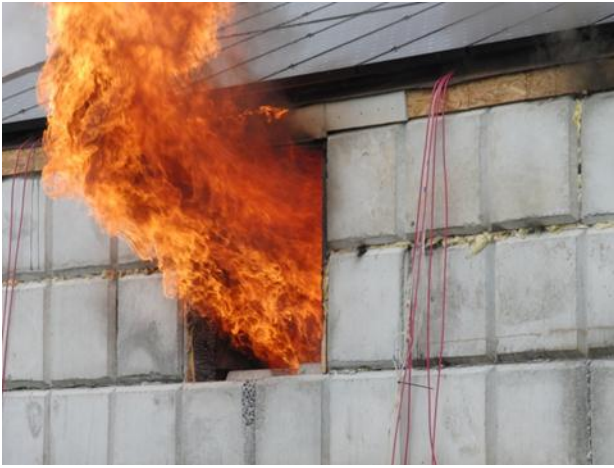
Figure 164 Flames propagate out window

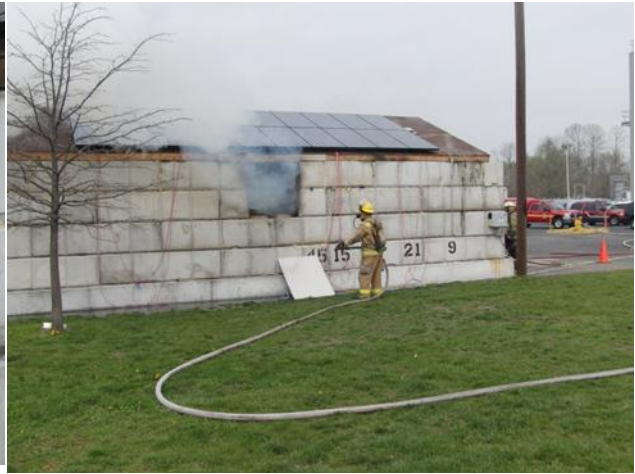
Figure 165 Fire terminated

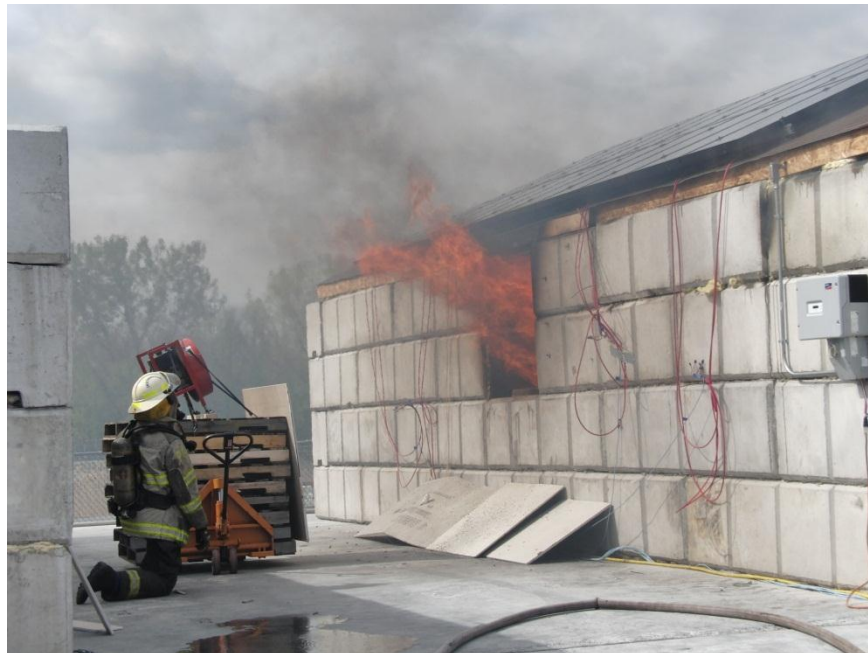
Figure 166 Fan used to help force flames towards roof

This test was repeated the following day under similar conditions, but with the addition a fire department ventilation fan in an attempt to direct air towards the window opening. The ambient wind conditions at the time of the test was with varying wind direction conditions of approximately 200 feet per minute toward the test structure. With the fan, the air velocity was measured to be approximately 500 feet per minute at the roofline. However, the fan did not overcome the local wind conditions and the experiment was terminated after 18 minutes.

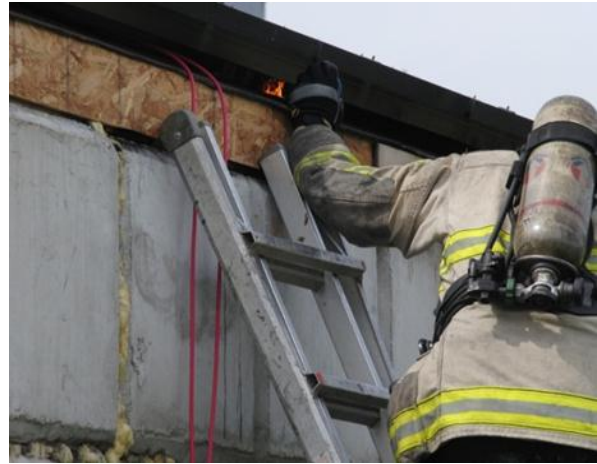
Figure 172 Igniting pine straw

Figure 171 and Figure 172 illustrate the roofing brand and pine straw fuel package positioned under the array and ignited.

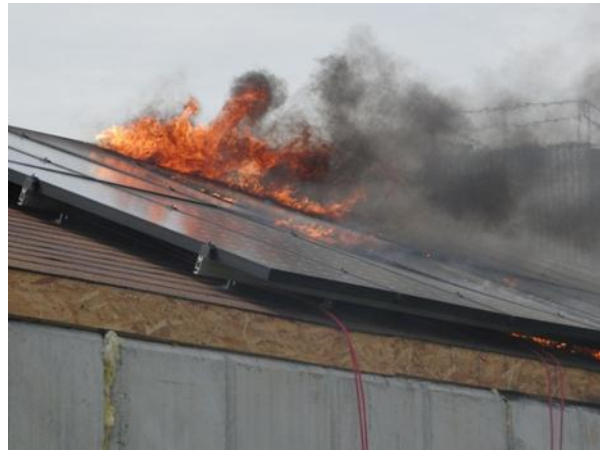
Figure 174 Flames spreading

Figure 173 through Figure 175 illustrate the fire spread under the array extending up to the roof peak. Figure 176 illustrates suppression of the roof and PV modules.

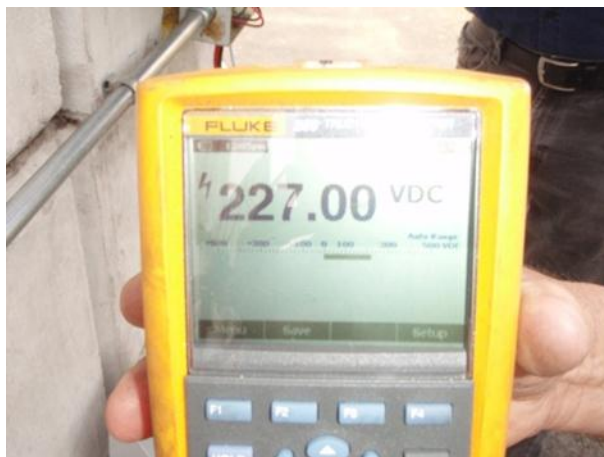
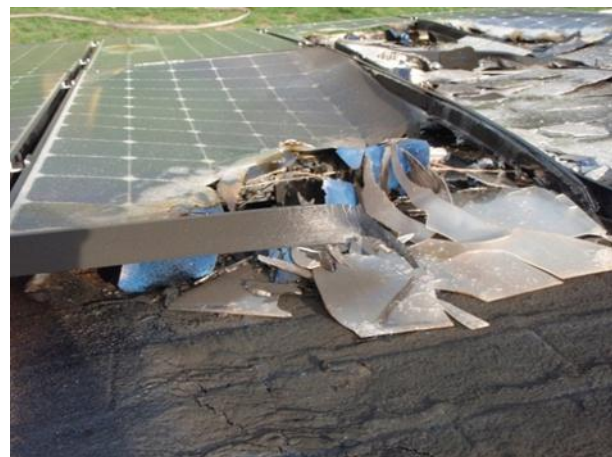
Figure 181 Installer identifies hazardous voltage Figure 182 Assessing Damaged Modules

With the assistance of the professional PV installation contractor, the situation of the fire damaged PV array was analyzed to determine if hazardous energy was still present, and how the array could be safely disassembled and removed from the roof to ground. From general observations of the array, modules C1, D1, C2, D2 and E1 were heavily damaged. Since there were voltage sense leads attached to the modules for test purposes, it was easy to determine that most of the remaining modules had full voltage. It should be noted that in a real fire situation, this would not be as easy to determine. Also, it was observed that the fire had damaged the wire insulation to many of the conductors, and also had melted the aluminum mounting rail in several places, thus possibly losing ground continuity.

Disassembling the array after the fire presented some challenges to the PV installer. Some options the installer considered was waiting until after dark, or using a tarp to block illumination to the modules. With the DC disconnect opened, the installer measured about 2 amps of current still within some portions of the array. This was likely the result of multiple ground faults. In the end, the installer chose to use electrical voltage rated rubber gloves and an insulated wire cutter to begin cutting wires to the modules on the roof. The rubber gloves were needed because blind reaching under a damaged module was often needed to get access to these wires, and it was not immediately known if the wires were damaged and bare conductor was present. Also, it was possible that frames of modules and/or sections of the aluminum mounting rail could be energized as the grounding system became compromised during the fire. The installer also used a hand-held voltmeter to periodically check voltages on exposed conductive parts. As each module was disassembled from the rail, and cut free from the string, it was handed down to a person at ground level for safe storage. An analysis of the modules on the ground showed that modules C1, C2, D1, D2, and E1 had been completely destroyed by the fire. Module E2 had a damaged bus and was producing about half rated voltage and current. The remaining modules were fully functional. Figure 181 and Figure 182 illustrate the extent of damage to the array and a voltage produced by the damaged modules.

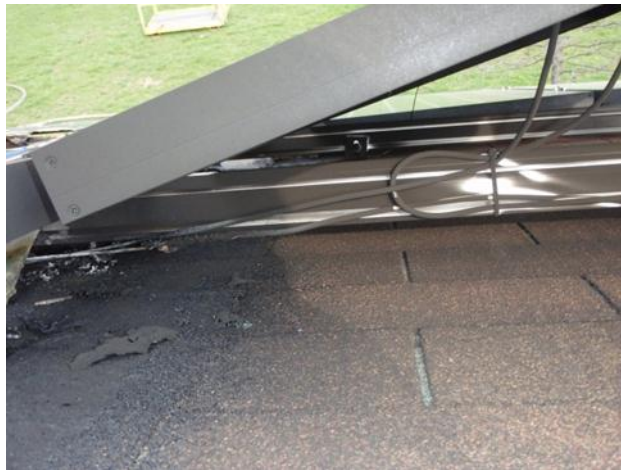
Figure 184 Looking under module for dangers

Figure 184 through and Figure 186 illustrate the technique used during the disassembly of the array after the experiment.

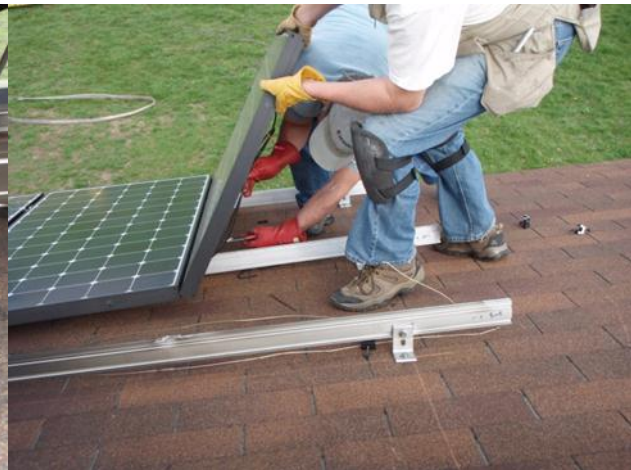
Figure 185 cutting leads

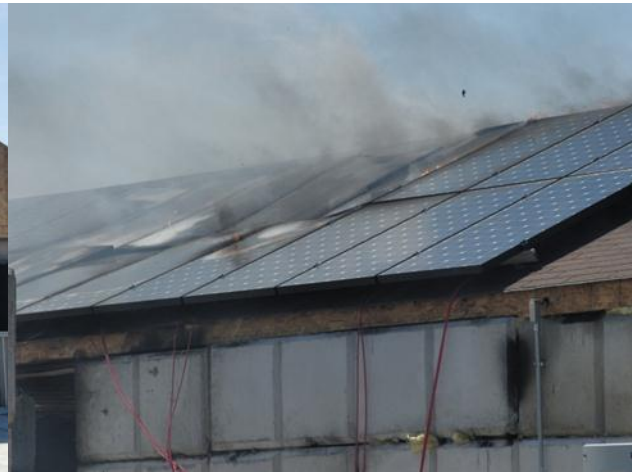
Figure 190 Smoke after pine straw burns

Figure 189 and Figure 190 illustrate the fire extension of the debris during the experiment.

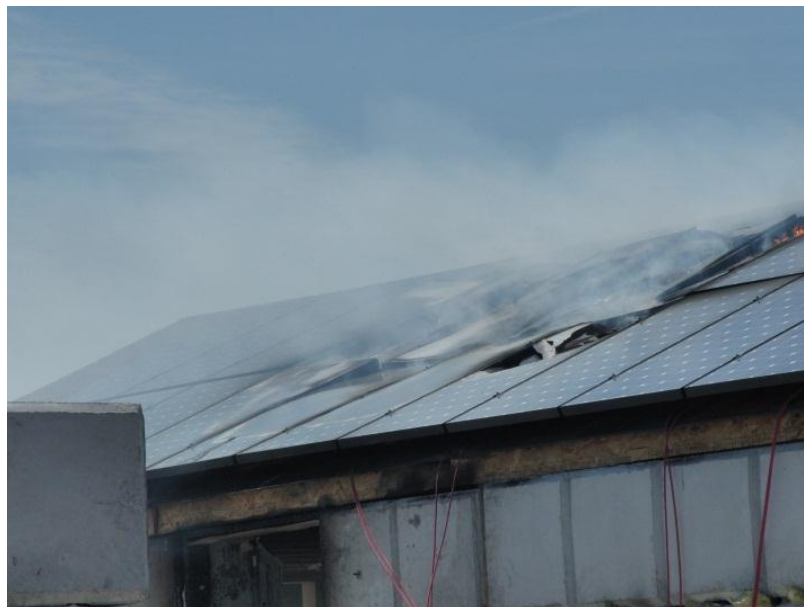
Figure 191 Broken glass and debris

Figure 191 illustrates the damage to the array prior to breaching into the attic.

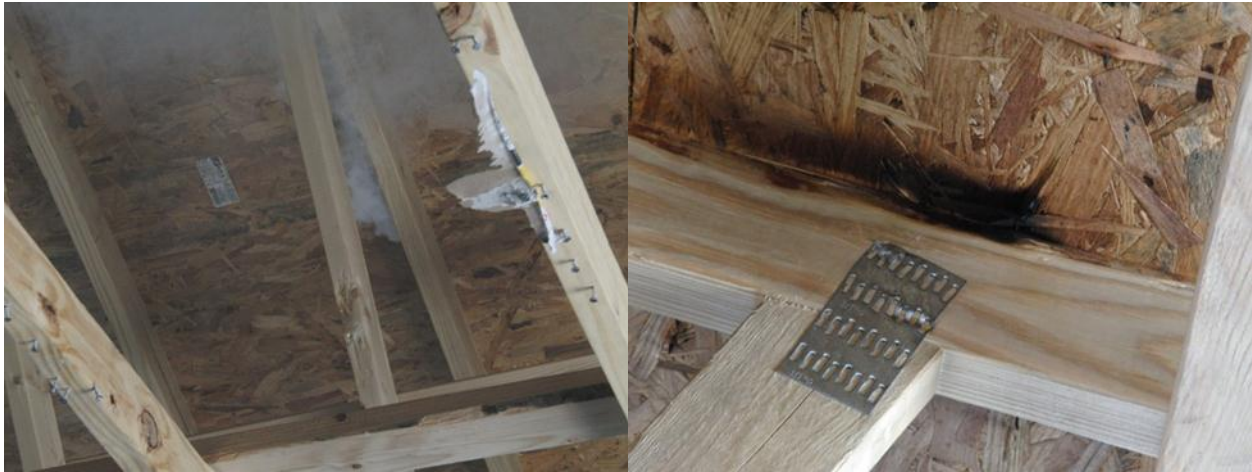
Figure 192 Smoke developing on inside of roof **Figure 193** Charring on inside of roof

Figure 192 and Figure 193 provides a view of the underside of the wood deck prior to breaching into the attic.
